Residual stresses in condition monitoring and repair of thermal power generation components

JAMES, Malcolm Neil, HATTINGH, Danie, ASQUITH, David, NEWBY, Mark and DOUBELL, Phillip (2017). Residual stresses in condition monitoring and repair of thermal power generation components. Theoretical and Applied Fracture Mechanics, 92, 289-297. [Article]

Residual Stresses in Condition Monitoring and Repair of Thermal Power Generation Components

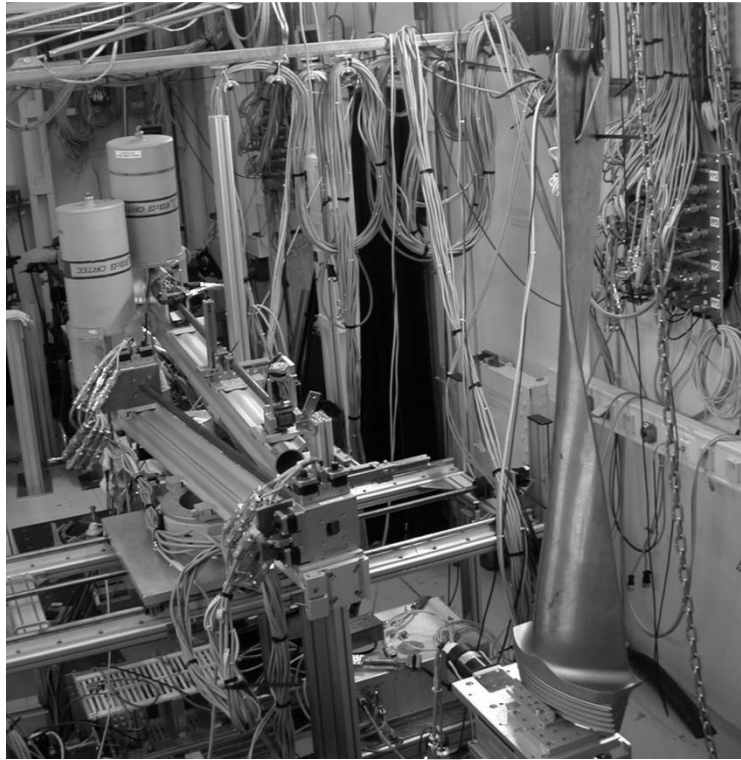
Figure 1 Bi-axial measurement of residual stresses in a 23kg 12CrNiMo martensitic steel turbine blade.

Further complexity in life prediction arises from the modification of residual stress during cyclic loading and there is no definitive guidance available to assist with predicting this effect. A classic example of this aspect of stress modification during fatigue cycling is the relaxation of shot peening stresses in the fir tree root region of steam turbine blades during service, which could lead to blade failures in low pressure steam turbines. Other work reported by some of the present authors [7] details the work done in characterising residual stresses and fatigue life prediction for the last stage blades in the low pressure turbines of a 600 MW turbo-generator set. The residual stress field in the fir tree blade attachment region was measured on new unpeened and peened blades, and on ex-service blades using high energy synchrotron X-ray diffraction. Figure 1 shows such a 23 kg last stage blade mounted on the stage of the ID15A instrument at the ESRF in France, for bi-axial measurements of the residual stress.

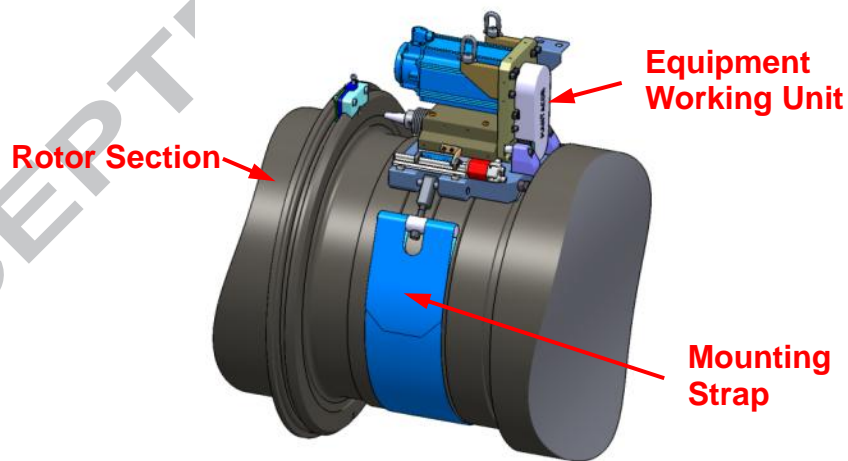
Figure 2 Illustration of the bespoke FTHP platform in position on a stream turbine rotor. It uses the registered WeldCore® process and is capable of extracting an annular metallurgical sample through the thickness of the blade attachment T-slot wall, repairing and re-drilling the hole in a single sequence of operations.

Turbine failures resulting from blade and rotor disc problems cost the power generation industry substantial annual amounts of money [17]. Alongside a desire to reduce these costs, there are strong additional economic pressures to move towards sample-based condition monitoring and a probabilistic fracture mechanics-based life assessment. It is therefore clear that more cost-effective techniques for assessment of creep damage and cracking, where the sampling procedure and repair process are integrated into a single operational platform, would be very attractive to power station operators. Hattingh et al in reference [17] discussed the deployment of an innovative bespoke friction taper hydro-pillar (FTHP) welding technique to repair stress corrosion cracks (SCC) in the central blade attachment prong of a last stage LP turbine disc in a 200 MW unit. The unique FTHP platform (see diagram in Figure 2) developed for this application has a modular design which enables site applications in various orientations and configurations. One such application required that the device be mounted on a high pressure (HP) steam turbine rotor and then performing a sequence of operations that included extracting annular samples from the highly stressed and inaccessible corner radius of the blade attachment T-slot for creep analysis, before repairing the hole by FTHP welding. This was followed by re-machining of the T-slot and heat treatment of the welded area. The technique employs the so-called WeldCore[®] process and the FTHP welding process, that is now accepted by ASME for inclusion as a new welding process in Section IX of their Boiler and Pressure Vessel Code [19].

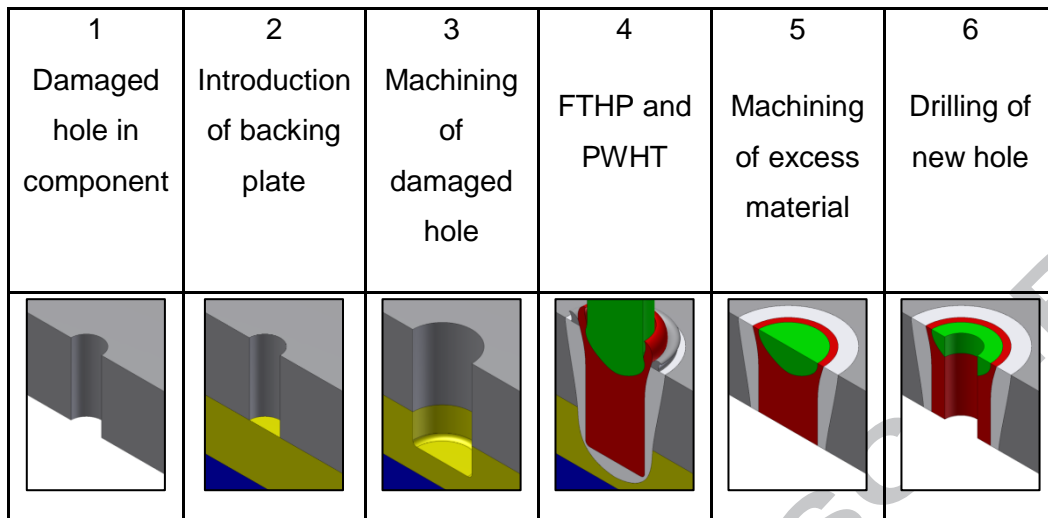
Figure 3a Stages in the FTHP repair of damaged turbine blade attachment finger holes in a LP rotor disc. Residual stress measurements were made on specimens representing stages 5 and 6 in both the as-welded and PWHT conditions

the German specification SEW 555 Grade 26NiCrMoV1-5 (ASTM A470 Class 5 to 7) representing the various stages in the repair process (see Figure 3). This work was performed at the ILL in Grenoble, France, in experiment 1-02-83 using the SALSA beamline. In this case, knowledge of the residual stresses was important in assessing the effectiveness of PWHT in reducing peak residual stress values to <100 MPa. The stresses during service (applied plus residual) would then be approaching those applicable to the original blade root attachment hole and the turbine could continue in operation with the operator anticipating a similar fatigue/SCC performance to the original blade, provided that significant weld defects are not present. When performed using optimum process parameters, FTHP leads to a defect population that is less numerous and generally smaller in size than that found with fusion processes. The PWHT involved heating the specimens (each 95 mm x 95 mm x 18 mm) in a furnace at 680°C for 1 hour followed by furnace cooling. Although the temperature of 680°C is above the typical manufacturing tempering range of 630 to 650°C, it is still sufficiently below the A_{C1} temperature for this steel (typically ranging from 750 to 780°C; A_{C1} is the austenite transformation start temperature on heating the steel) and the PWHT was therefore intended to achieve maximum stress-relaxation by reducing the yield strength of the material to the level of an acceptable residual stress (<100 MPa). The effectiveness of PWHT is illustrated in Figure 4, which shows the Vickers microhardness profile at three depths in the 18 mm thick W5 specimen (undrilled with PWHT); it is clear that they have been substantially reduced from the peak values of ~ 500 H_V observed with the as-welded and undrilled specimen (W2). Note that the coordinate axes are defined as x and z transverse to the hole and y is defined through the thickness with zero at the upper surface of the specimen. Figure 5 compares the residual stress at three depths in specimen W2 with W5; peak magnitudes are reduced from circa 400 MPa to 500 MPa to <100 MPa. The results also indicated that drilling an 8 mm hole in the as-welded specimen (W3), to simulate a new pin attachment hole, led to a positive residual stress near the free surface in the x and y -coordinate directions; PWHT (W4) then decreased the magnitude of the residual stress around the hole to < 100 MPa in all three coordinate directions [17].

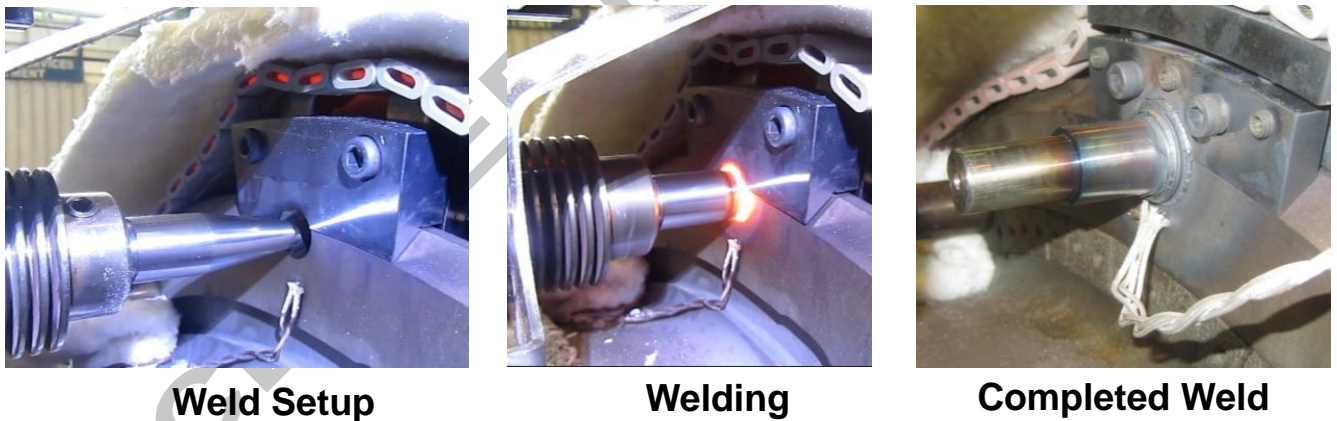
Figure 3b Images showing the welding stages in the FTHP process.

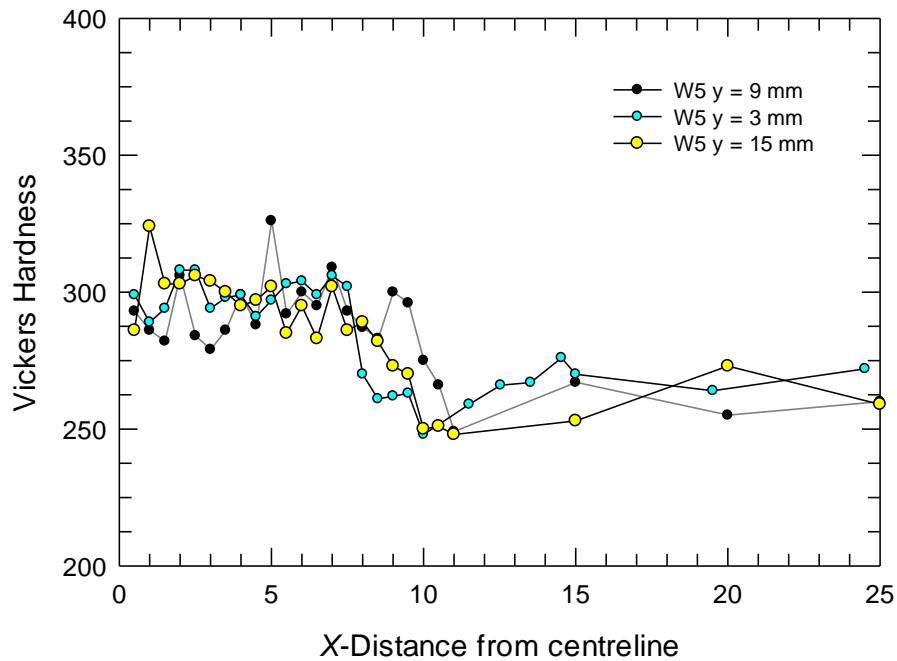
Figure 4 Vickers hardness profiles under a 500gf load in specimen W5 (un-drilled and PWHT) at three depths in the 18 mm thick steel.

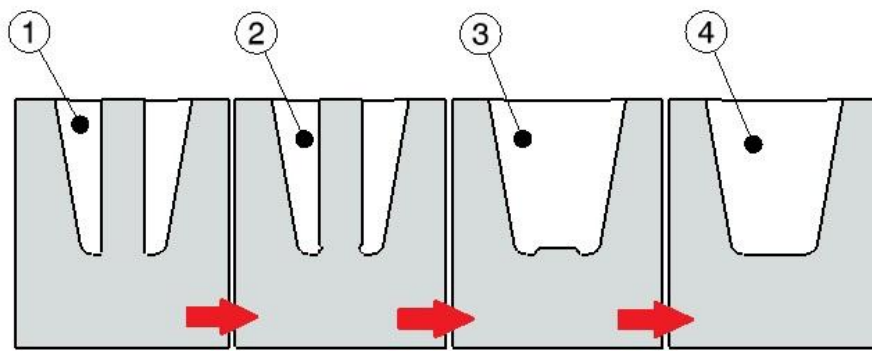
Figure 6a Sequence of events that occur in the WeldCore® process using a bespoke FTTHP processing platform. Stage 1 delivers a cored hole; stage 2 undercuts the core, stage 3 is after core removal and stage 4 represents a hole prepared for repair.

The sequence of events in the WeldCore® creep sampling process is shown in Figure 6. In the original planning for this experiment, specimens were prepared from two locations spaced at 90° intervals around the circumference of the pipe. At each position one as-welded specimen and one specimen that had been subjected to localised post-weld induction heat treatment were prepared. However, in the beamtime available in Experiment 1-02-128 it became necessary to concentrate the residual stress measurement effort on a single as-welded specimen (1A) and on a single specimen (2B) that had been welded and subjected to in-situ PWHT by induction heating. Figure 7 illustrates the PWHT of the pipe specimen using an induction heating coil and a thermally insulating pad. The specimens 1A and 2B were cut from circumferential positions 90° apart and a direct point-based comparison between the residual stresses before and after PWHT is therefore not possible. This highlights the point that in real life structural engineering, even when using advanced neutron diffraction strain scanning instruments, it is difficult to obtain sufficient access to beamtime to perform all the necessary experiments to underpin the industrial adoption of new techniques and processes.

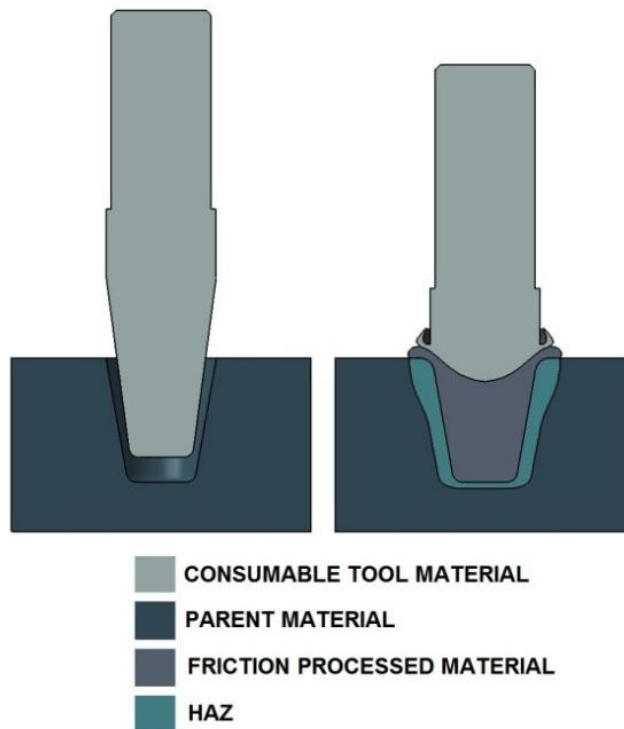
Figure 6b This diagram represents the final stage in the WeldCore® process where the prepared hole is filled by friction taper hydro-pillar processing (FTTHP).

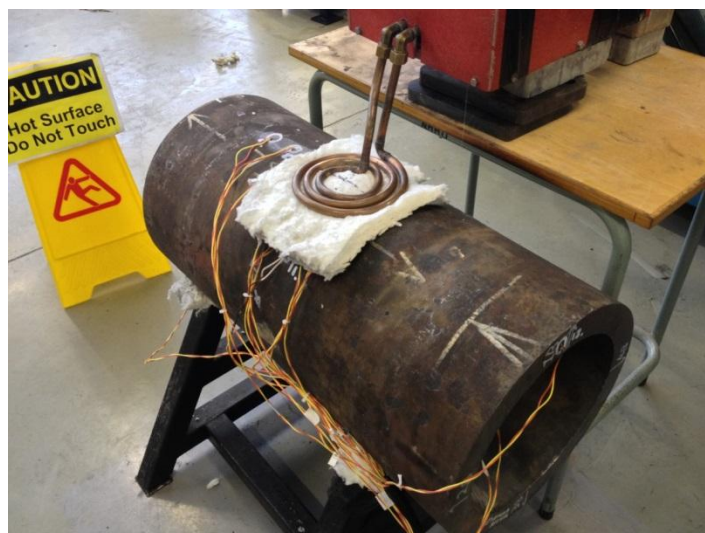
Figure 7 Induction heat treatment of the pipe after completion of the WeldCore® process.

number 1.7380). The PWHT was limited to a maximum surface temperature of 800°C and induction heating was continued until the inner surface of the pipe reached 650°C which was then maintained for a minimum of 15 minutes. Cooling took place in still air conditions in the laboratory.

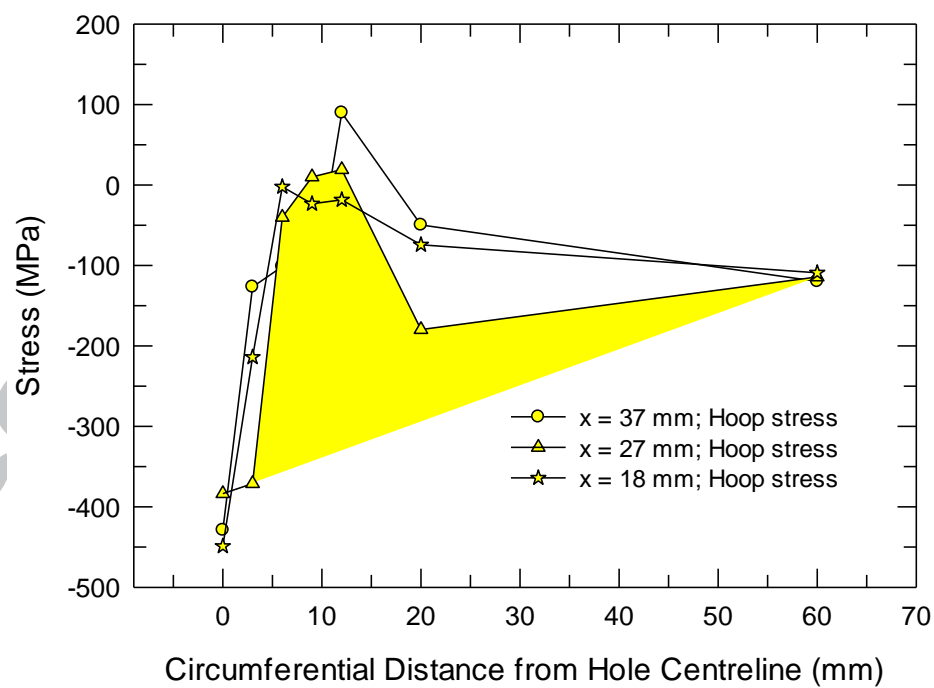
Figure 8a Residual hoop stresses in the as-welded FTHP specimen 1A.

Measurements were made of the residual stresses in the hoop, radial and axial directions of the pipe at three positions through the wall thickness (18 mm, 27 mm and 37 mm from the outer surface) at a number of positions from the weld centreline to a distance of 60 mm. Figure 8 shows the measured residual hoop stresses in specimen 1A (as-welded – Figure 8a) and specimen 2B (PWHT – Figure 8b) while Figure 9 shows the corresponding data in the axial direction. In terms of crack initiation during service, these are the two key coordinate directions. Measurements were able to be made at 5 depths in the PWHT specimen, while data was obtained at only three depths in the as-welded specimen.

Certain observations can be made from these hoop stress data; firstly, that at depths of 18 mm, 27 mm and 37 mm below the surface of the pipe, the large negative peaks that occur around the edge of the weld metal are reduced from peak values in the range 380 MPa to 450 MPa in the as-welded state, to values after PWHT in a range around 275 MPa to 380 MPa. Secondly, the values of peak tensile hoop stress are also reduced at equivalent depths and, thirdly, the stress distribution moves in the tensile direction the closer to the outer surface the measurements are made (e.g. Figure 9b, $x = 9$ mm and $x = 4$ mm). In all cases where data was obtained, the level of peak tensile residual hoop stress is < 120 MPa.

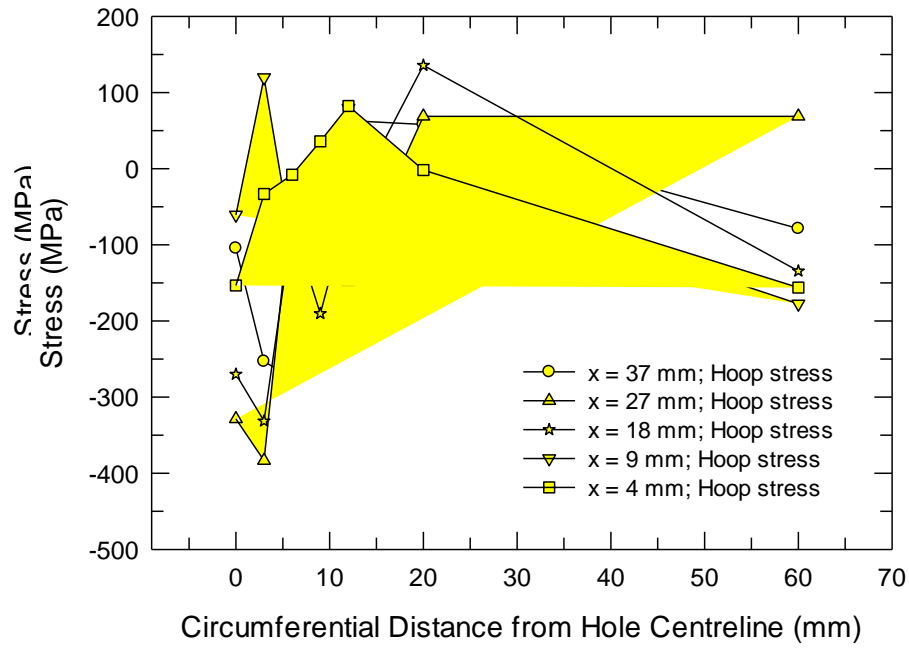
Figure 8b Residual hoop stresses in specimen 2B after local PWHT by inductive coil.

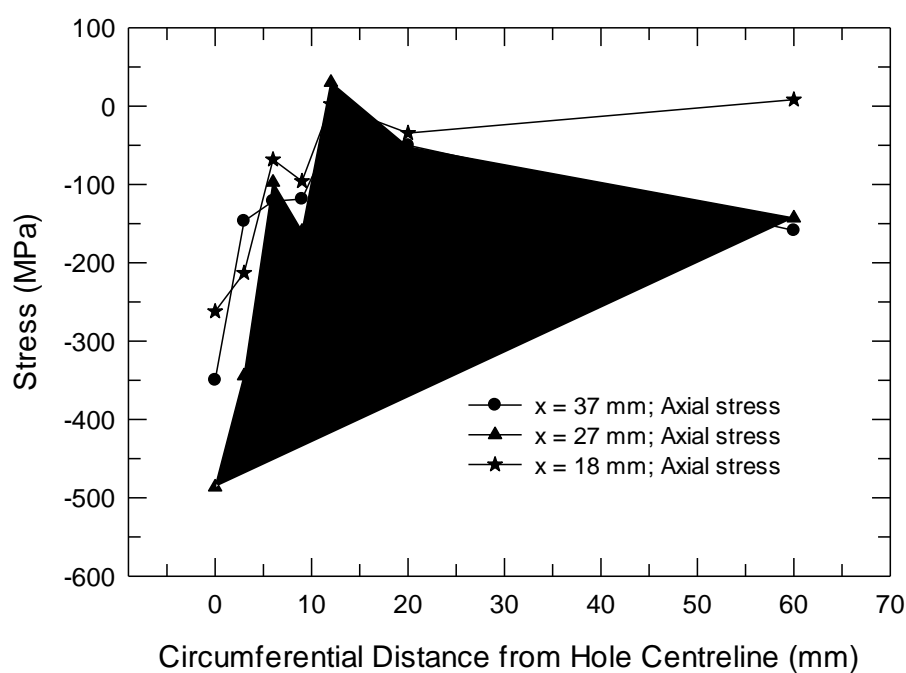
Figure 9a Residual axial stresses in the as-welded FTHP specimen 1A.

The same general observations are true of the axial stress measurements, although there is a significant difference in that the PWHT appears to sharply increase the stress variation across the heat-affected zone (HAZ) of the weld, between distances of 9 mm and 20 mm from the weld centreline. Peak values of tensile axial stress in all cases are < 140 MPa. Although experimental difficulties led to a smaller set of residual stress measurements than originally planned, it is clear that the FTHP technique can be usefully employed for in-situ through-thickness creep sampling and that the level of tensile residual stress in the pipe wall is $< 50\%$ of the lower yield strength of the steel. Localised PWHT reduces the peak negative stresses by some 16% in the hoop direction in the pipe and by up to 38% in the axial direction. A number of different in-situ applications of the FTHP technique have so far been successfully completed within the power generation and petrochemical industrial sectors.

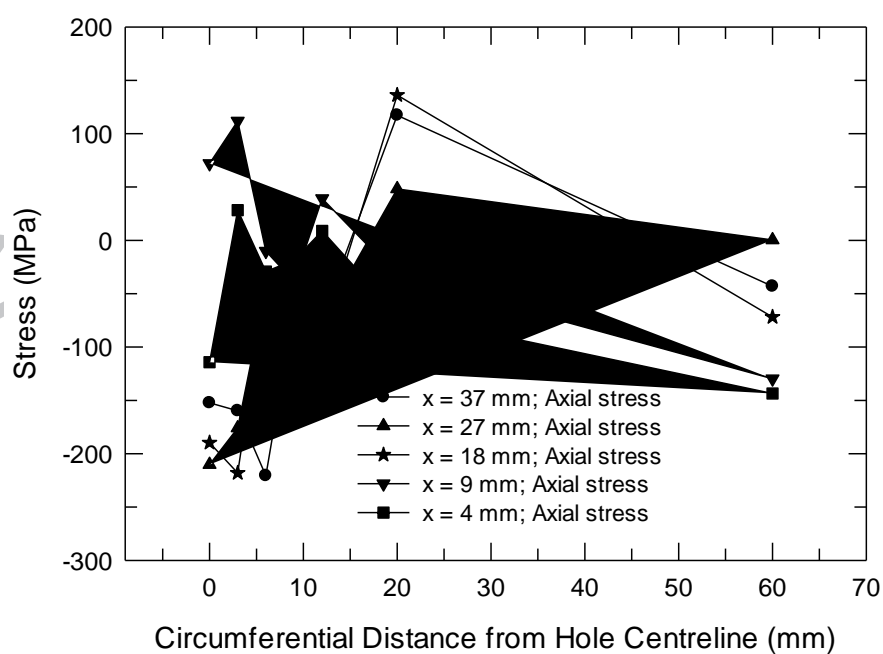
Figure 9b Residual axial stresses in specimen 2B after local PWHT by inductive coil.

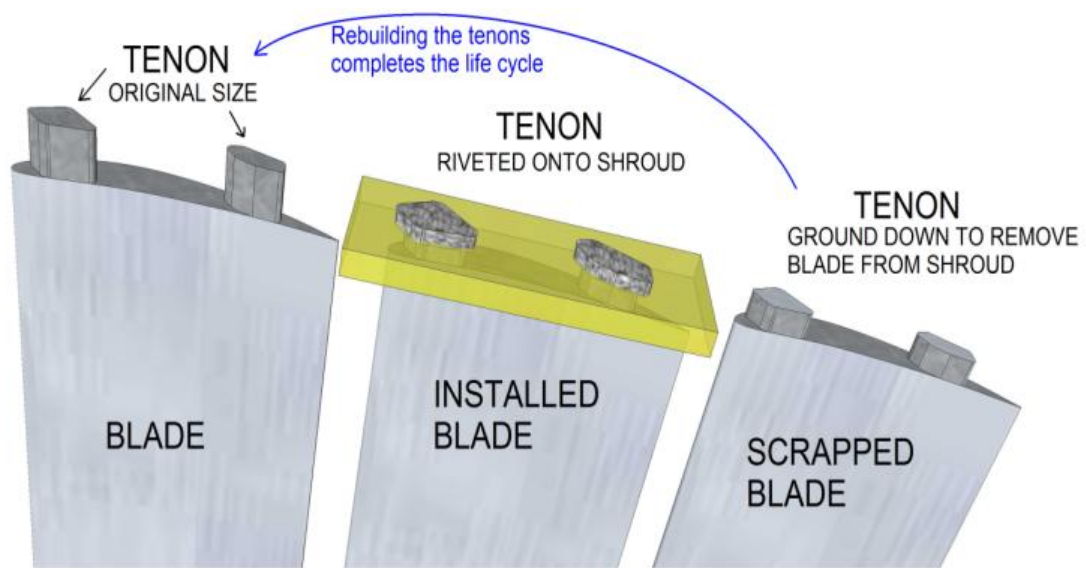
Figure 10 Schematic illustration of the tenon rebuild issue.

Tenons on turbine blades are used to position and fix the tips of adjacent blades in a shroud, whose function is to control the in-service vibration response of the blades. During turbine maintenance a large number of turbine blades have to be scrapped when their tenons are ground down in order to remove the blades for inspection or other maintenance activities. Typically, the estimated replacement cost of a row of blades is €60,000; and although in some cases only single blades have to be replaced, this still requires a number of adjacent blades to be scrapped in order to access and replace the damaged blade. Blades removed from the disc cannot be re-used as the remaining tenon stub is too short to be riveted to the shroud a second time. Figure 10 shows a typical blade tenon configuration and illustrates the problem that arises from tenon grinding to remove the shroud.

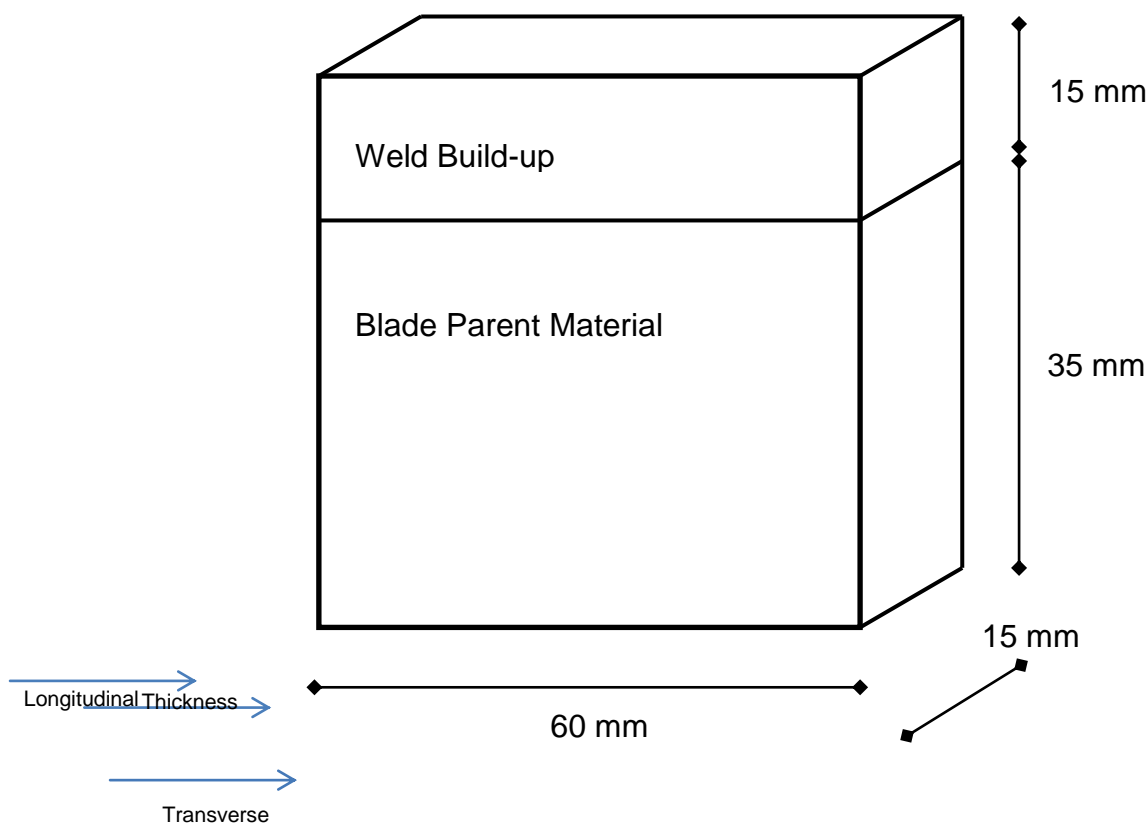
Figure 11 Geometry of the DIN 1.4939 steel coupon used to simulate tenon build-up by laser welding. The three orthogonal directions for residual stress measurement are longitudinal (L), transverse (T) and short-transverse or through-thickness (ST).

Residual stress data were measured on the SALSA beamline at the ILL, Grenoble in Experiment 1-02-152 for simulated blade specimens in the as-welded and PWHT conditions for both welding processes. Neutron diffraction measurements were made using a collimated beam ($\lambda = 1.644\text{\AA}$) and cadmium shielding of the samples, resulting in a gauge volume of $0.6 \times 0.6 \times 12$ mm. The 0.6 mm dimension was required for fine spatial resolution across the heat affected zone. The specimen geometry used to simulate the built-up, un-machined tenon is shown in Figure 11 and takes the form of rectangular coupons $60 \text{ mm} \times 50 \text{ mm} \times 15 \text{ mm}$ machined from ex-service Grade FV566 martensitic stainless steel turbine

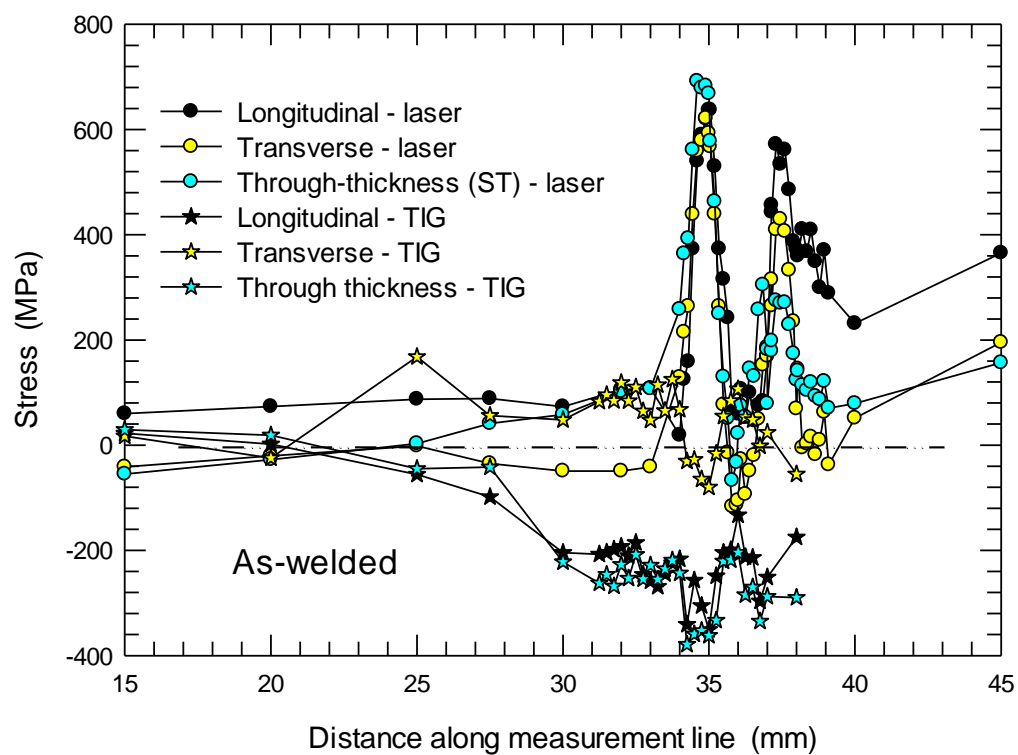
Figure 12a Residual stress data measured in the as-welded laser (specimen 2) and TIG welded (specimen 5) tenon samples.

The resulting 3D residual stress data are shown and compared for the two cases in Figure 12a (as-welded) and Figure 12b (PWHT). The zero point for the x-axis of Figure 12 is the bottom surface of the test coupon, so the original fusion boundary is at $x = 35$ mm.

For the laser welded specimen in the as-welded condition, it is clear that a substantial level of triaxial tensile stress exists on either side of the fusion boundary with peak values of circa 600 MPa. Across the fusion boundary the peak stresses reduce in magnitude with the values in the T and ST directions tending to be negative, while the longitudinal stress remains tensile. The turbine blade tenons in an as-welded state would hence be exposed to a significant risk of experiencing SCC, hydrogen-assisted cracking or fatigue. In contrast after PWHT, the residual stress peaks are more localised around the fusion boundary transition and the peak tensile values are reduced to between 100 – 120 MPa. A small region (≈ 2 mm wide) of triaxial tension still remains associated with the fusion boundary zone. PWHT has therefore been quite successful in the laser welded case in reducing residual stress magnitudes and hence in reducing the possibility of crack initiation and growth during service.

The TIG welded specimens show rather different behaviour with tensile stresses occurring near the fusion boundary for the as-welded case only in the transverse direction and having peak values < 200 MPa. Measured residual stress values are negative in the L and ST directions with peak values much greater (circa – 400 MPa) than those observed with the laser welding (circa -100 MPa). For the PWHT TIG welded specimen the overall pattern of the residual stress field is similar to that observed for the laser welded case although peak negative values of stress are significantly higher in the TIG welded case at around -400 MPa than the values in the laser welded case (-300 MPa). The PWHT appears to primarily have affected residual stresses in the transverse direction and has made them more negative.

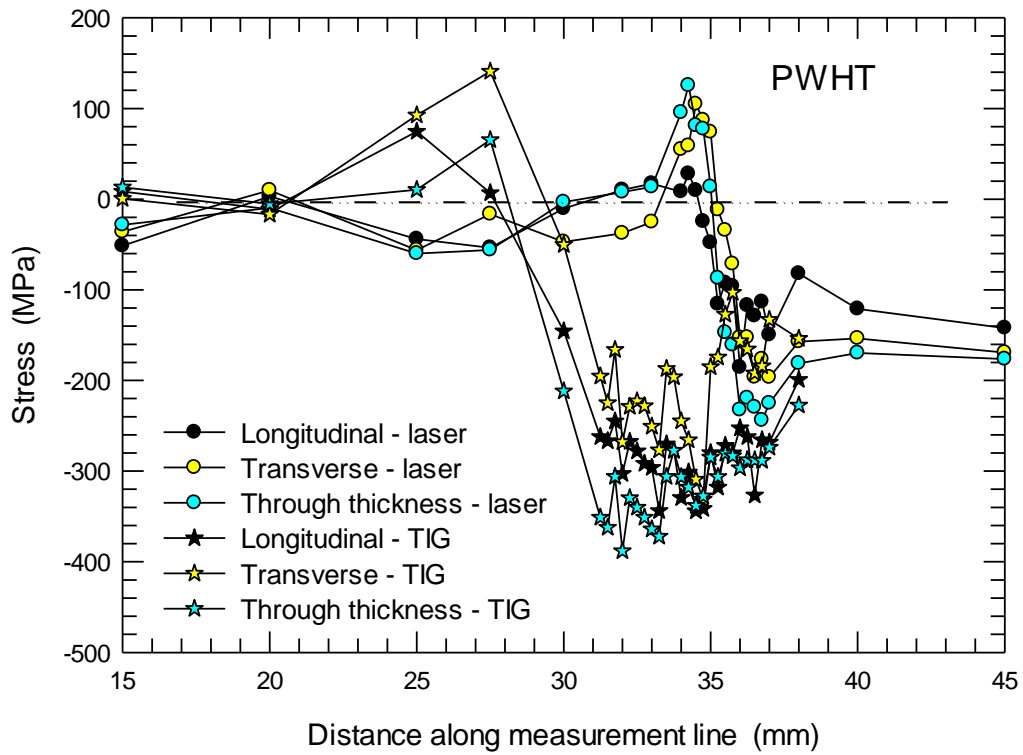
Figure 12b Residual stress data measured in the PWHT laser (specimen 1) and TIG welded (specimen 4) tenon samples.

The heat input during welding is far lower for the laser process. This results in a narrower heat affected zone and significantly less distortion of the tenon build up. The difference between the as-welded condition residual stresses is largely due to the over-bead tempering effect during the TIG process. After PWHT the residual values are similar in amplitude, but the residual stresses in the TIG welded sample still dissipate further from the fusion zone.
