## **Shear behaviour of crushed concrete and bricks**

CHIDIROGLOU, Iordanis, O'FLAHERTY, Fin and GOODWIN, Andrew (2009). Shear behaviour of crushed concrete and bricks. *Proceedings of the Institution of Civil Engineers. Construction Materials*, 162 (3), 121-126.

Title: Shear behaviour of crushed concrete and bricks

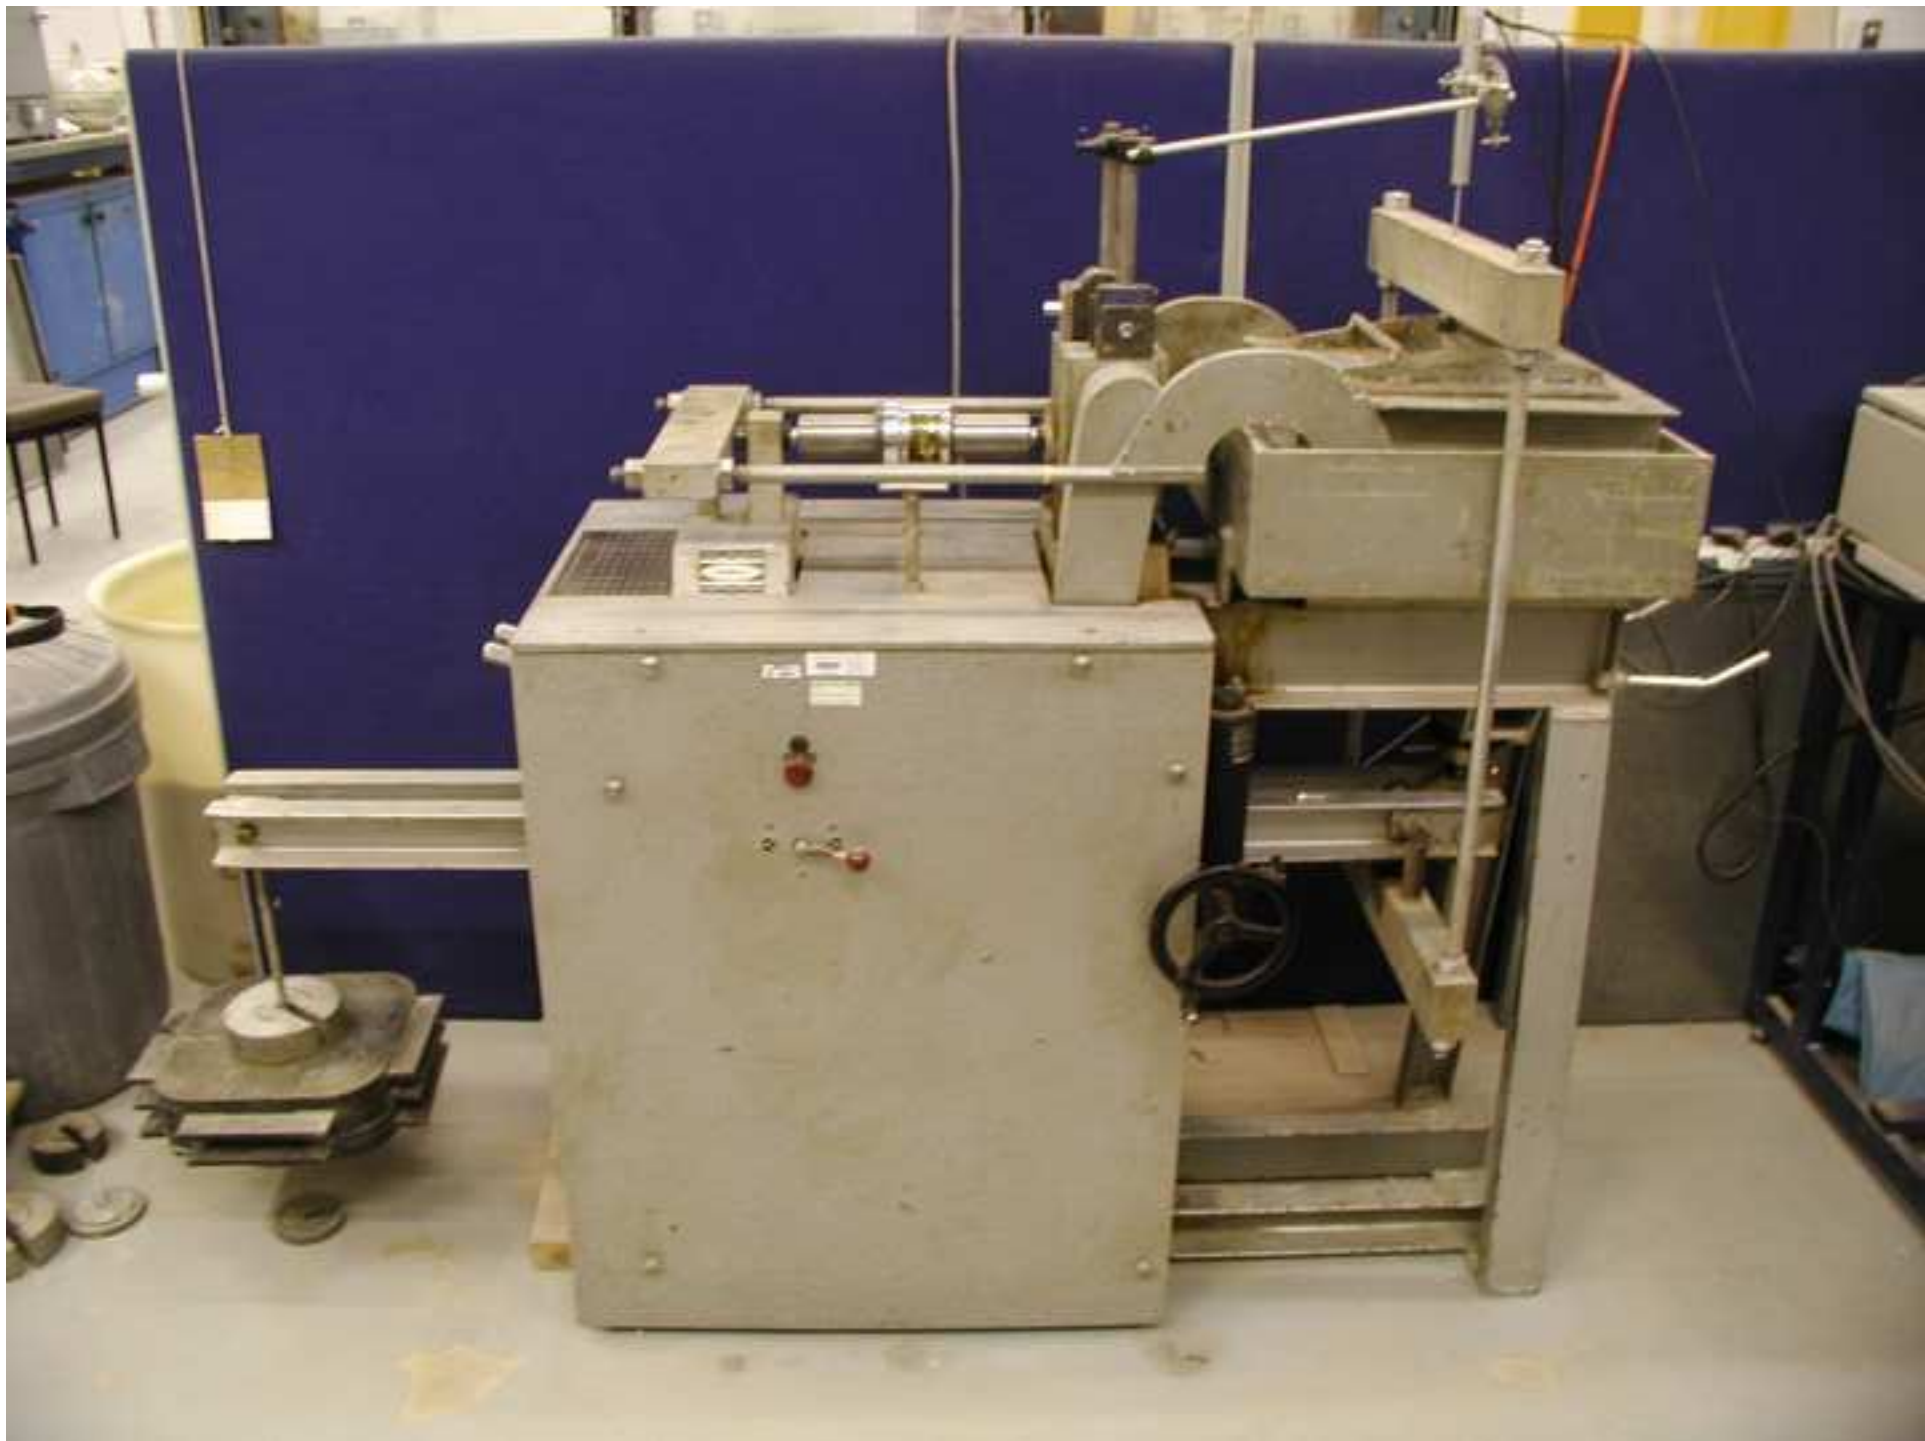
Figure 2  
[Click here to download high resolution image](#)

The shear box equipment used in the test programme is shown in Fig. 2. The apparatus is free-standing and consists of a rigid base frame supporting a central horizontal loading jack. The thrust from the jack is applied to the lower half of the ball track mounted shear box, measuring 316 mm square by 160 mm high. The upper half of the shear box is attached to another horizontal loading jack, which is connected in turn to a 50 kN capacity load cell. The horizontal loading jacks are driven via a multi-speed gear box mounted within the base of the machine. Vertical load is applied to each specimen through a rigid loading plate and a vertical loading frame. The lower crosshead of the loading frame passes beneath a horizontal loading beam, which transfers dead load from the end of the beam at a ratio of 20:1.

Fig. 2. Large shear box apparatus
