Structural Integrity Modelling of an Early Bronze Age “Corridor House” in Helike of Achaia, NW Peloponnese

Structural Integrity Modelling of an Early Bronze Age “Corridor House” in Helike of Achaëa, NW Peloponnese

Mariza Kormann, Stella Katsarou, Dora Katsonopoulou
and Gary Lock

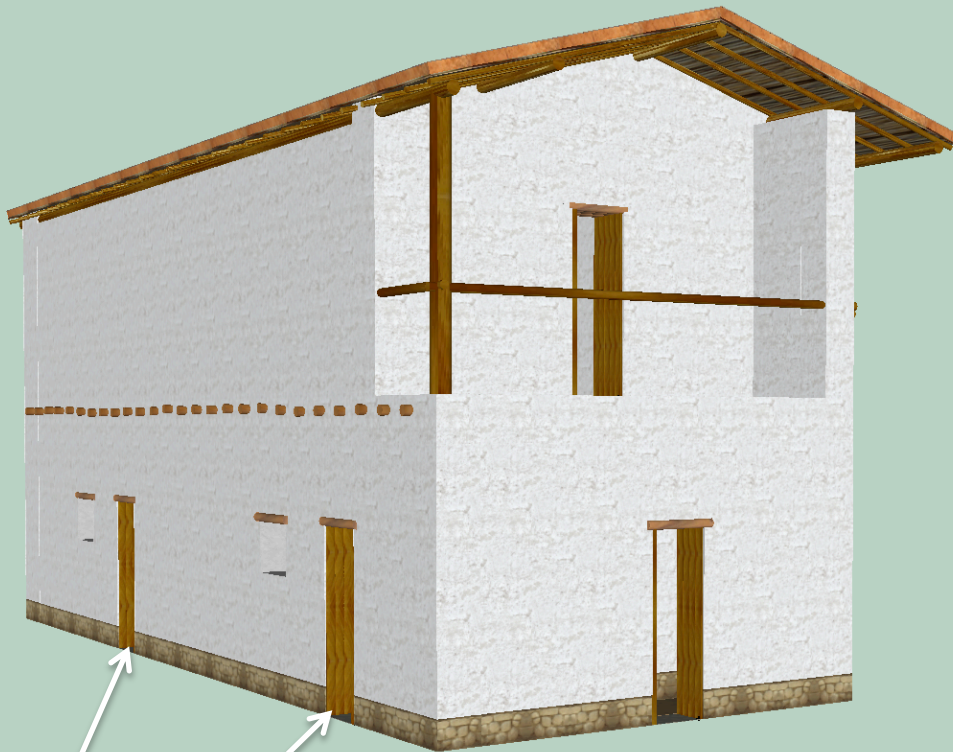
View from the North East

Stairway to upper floor
Large room at the back

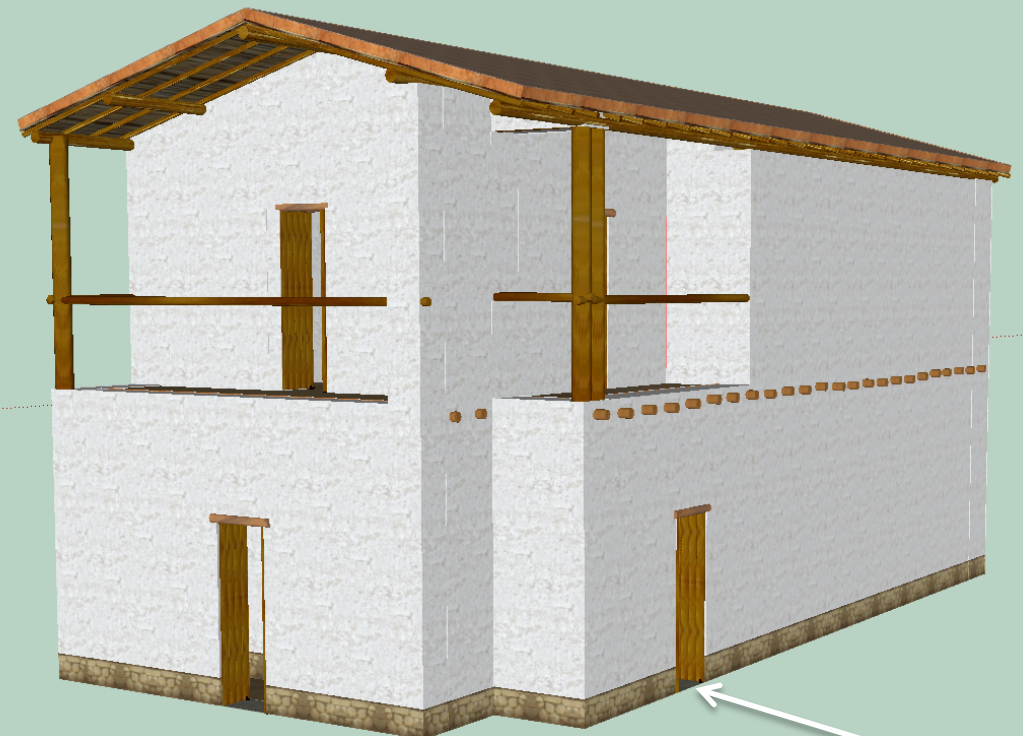
View from the North West

Small room with external access only

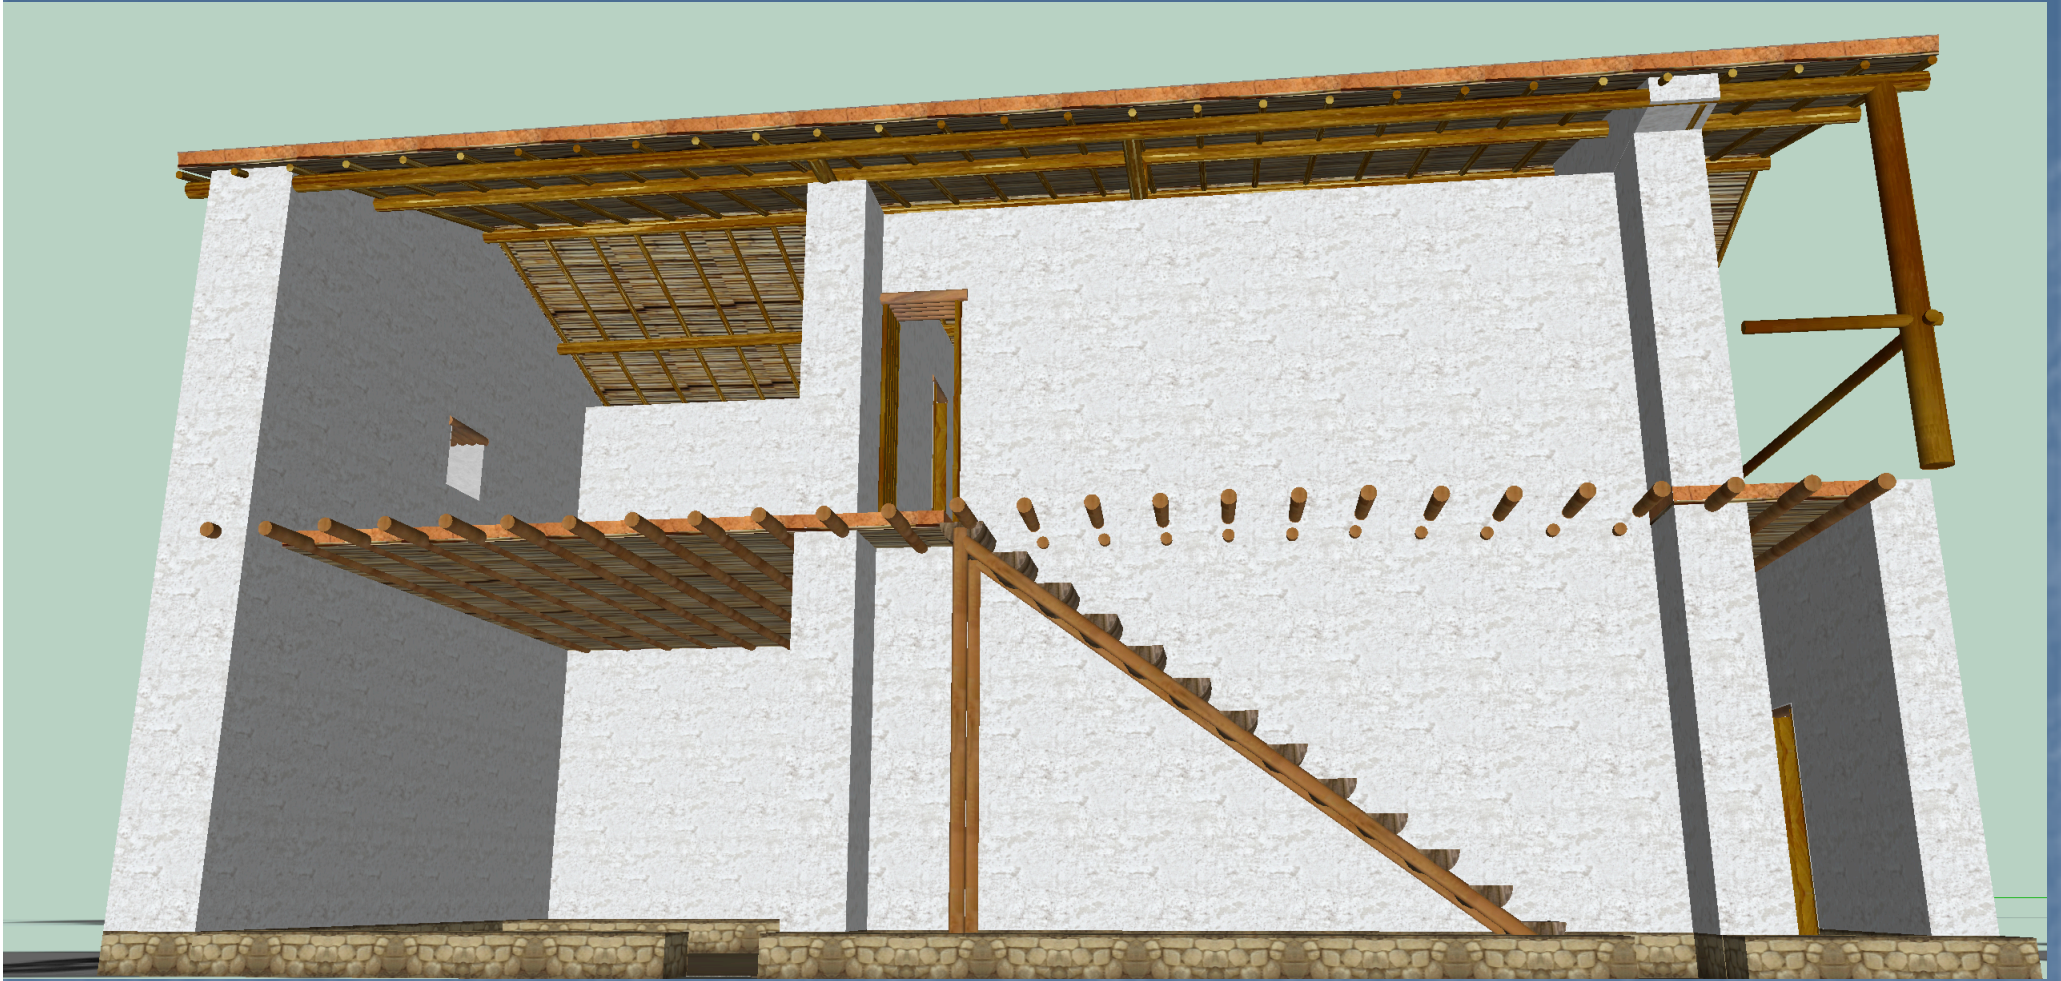
Roof and upstairs floor

- Roof
 - Wooden structure, reeds, rammed earth, tiles
- Upstairs floor
 - Wooden structure, reeds, mud
- Staircase
 - Wooden structure

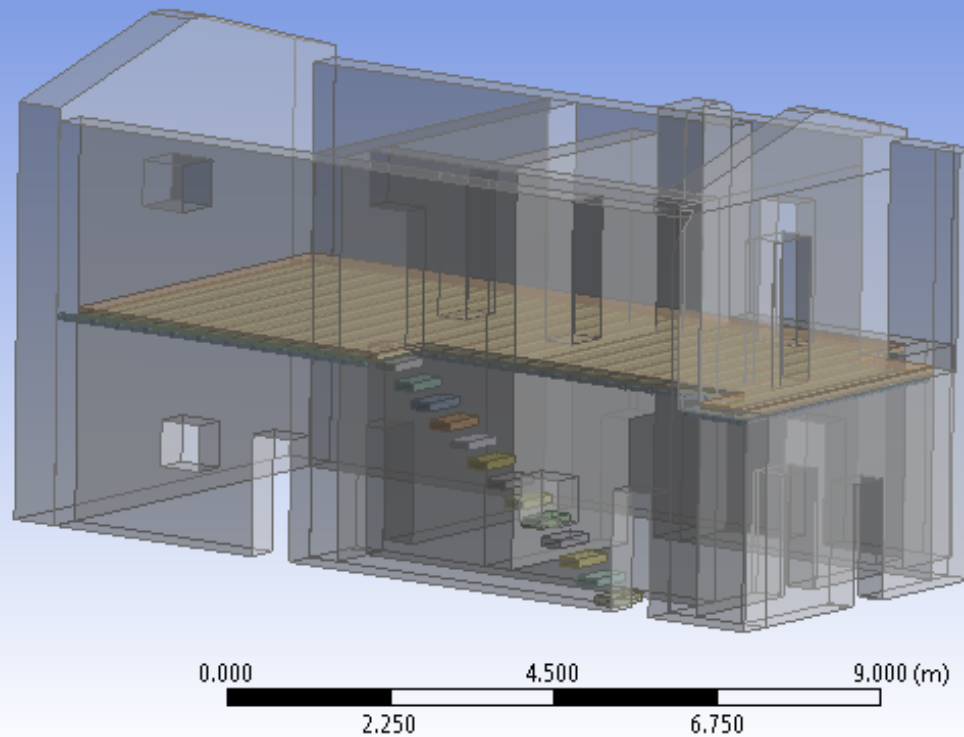
Importing Geometry

ANSYS
R15.0
Academic

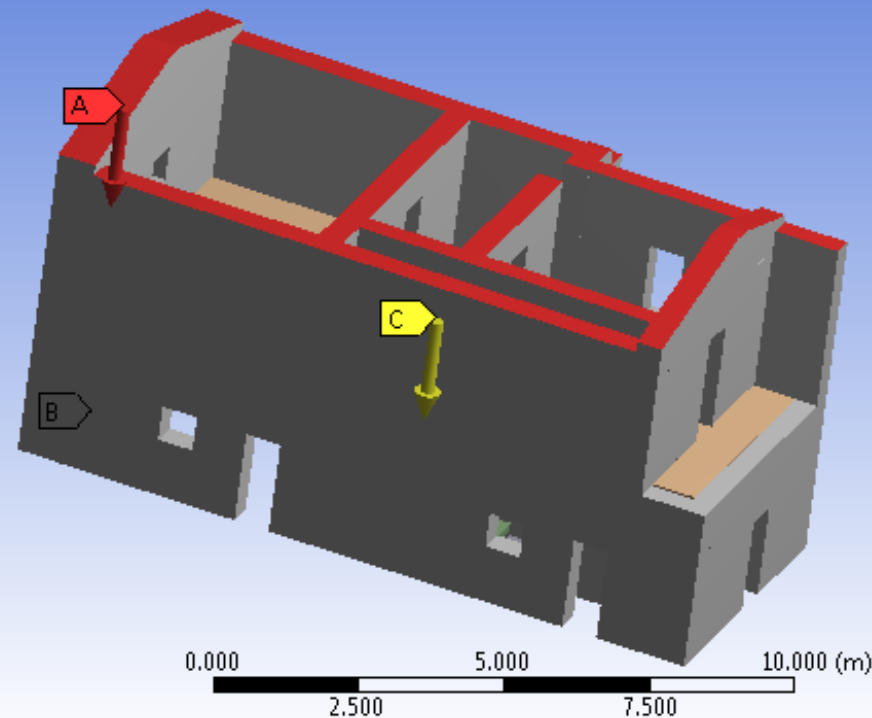
Setting up External Loads

A Force: 2.6224×10^5 N

B Fixed Support

C Standard Earth Gravity: 9.8066 m/s^2

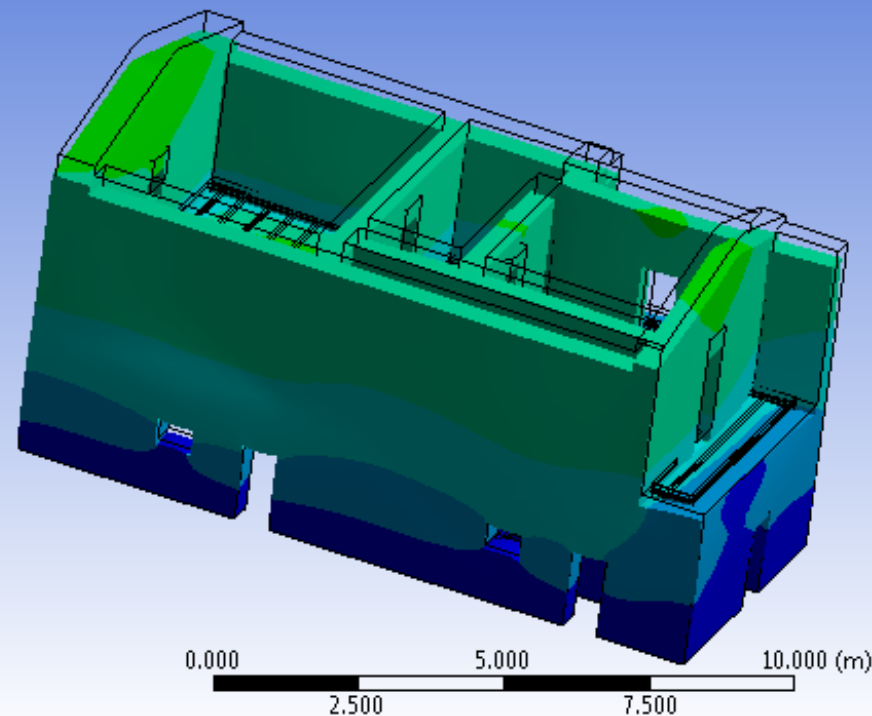
Results: Static Structural Analysis Total Deformation

Type: Total Deformation

Unit: m

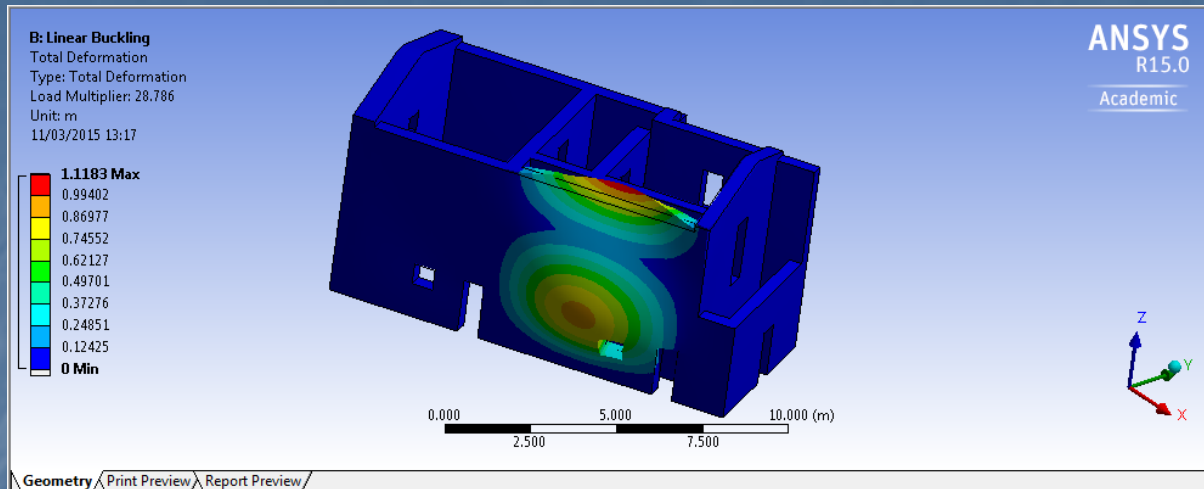
Results: Linear Buckling

No floors
No stairs

- Design and materials capable of supporting second floor
- Wall more susceptible to buckling is the outer wall to the stairs
- Adding first floor and staircase makes that wall less susceptible to buckling
- Transversal walls at 90 degrees on the corridor on the west side of the house makes the structure more rigid

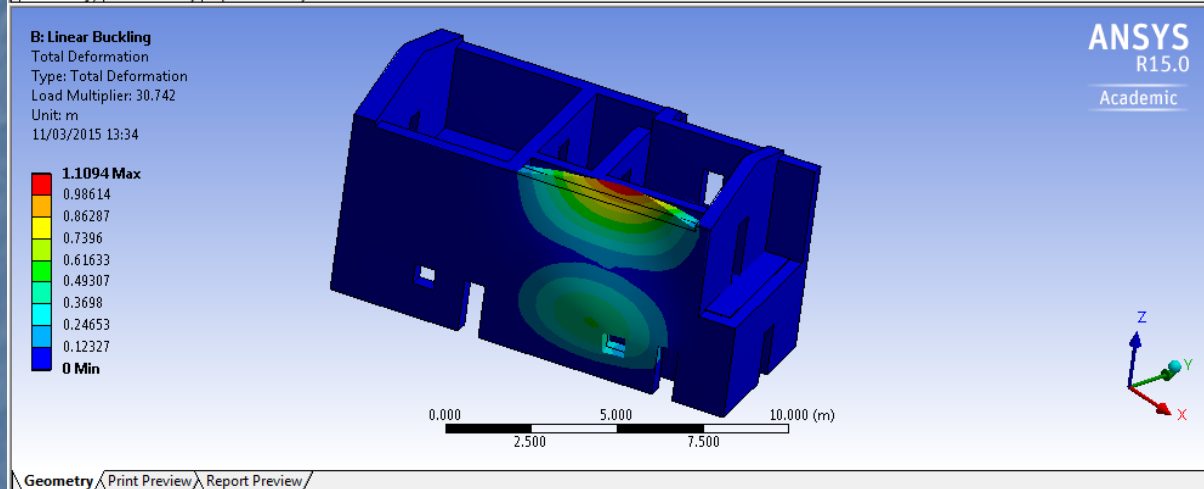
With floors
No stairs

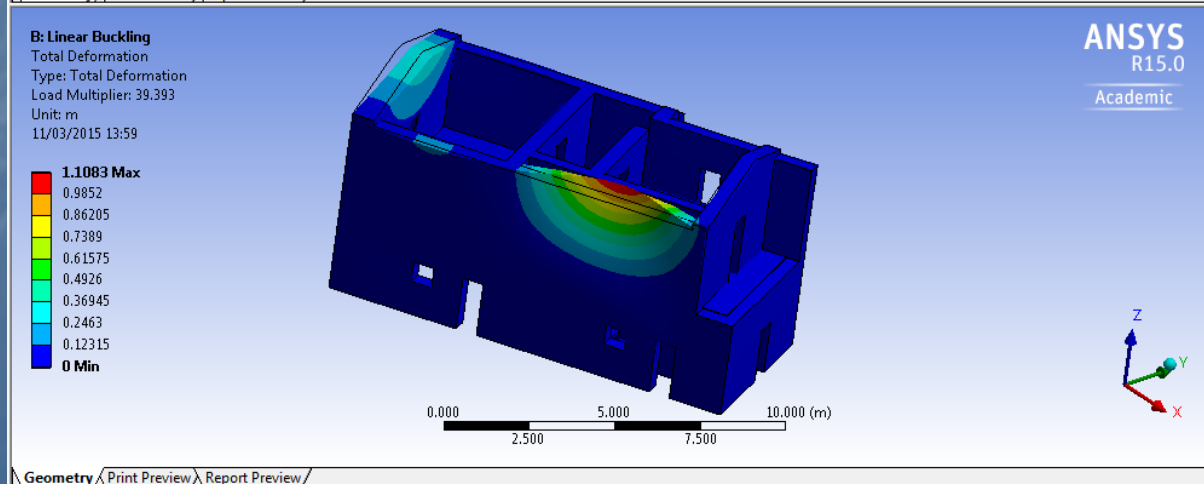
With floors
With stairs
