Structural Integrity Modelling of an Early Bronze Age “Corridor House” in Helike of Achaea, NW Peloponnese

Structural Integrity Modelling of an Early Bronze Age Corridor House in Helike of Achaea, NW Peloponnese, Greece

Keywords: Helike, Corridor House, Early Helladic Architecture, Structural Integrity, Finite Element Analysis

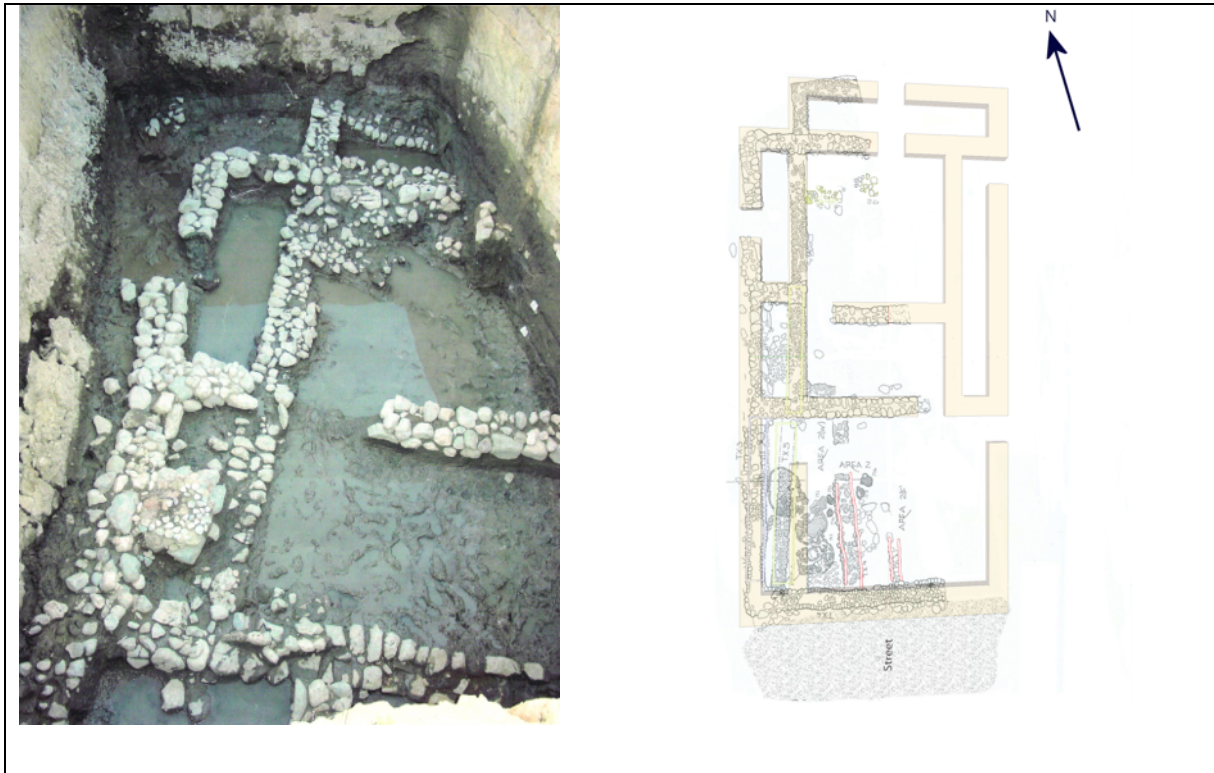
The house plan geometry is derived from accurate measurements of the excavated foundation walls at the EH Helike site. Figure 2 shows part of the excavated foundation walls during the 2003 season and a corresponding drawing of the HCH with added conjectural plan that was used to guide the 3D reconstruction. Figure 3 illustrates two views of the 3D reconstructed house performed in SketchUp.

Figure 2: Left: view of the north western part of the HCH during fieldwork in 2003; right: full drawing of the ground plan.

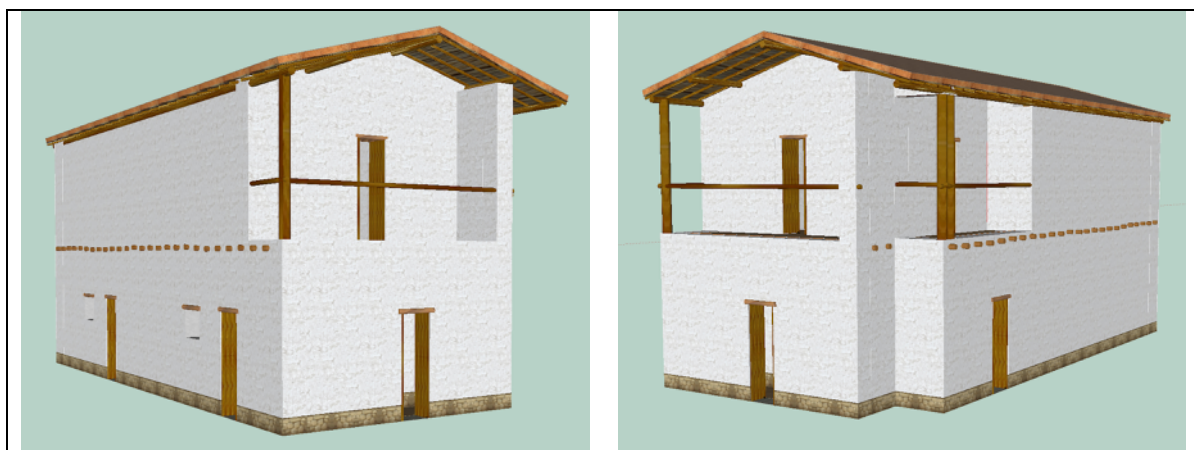
Figure 3: The 3D model of the HCH, based on the house plan of Figure 2.

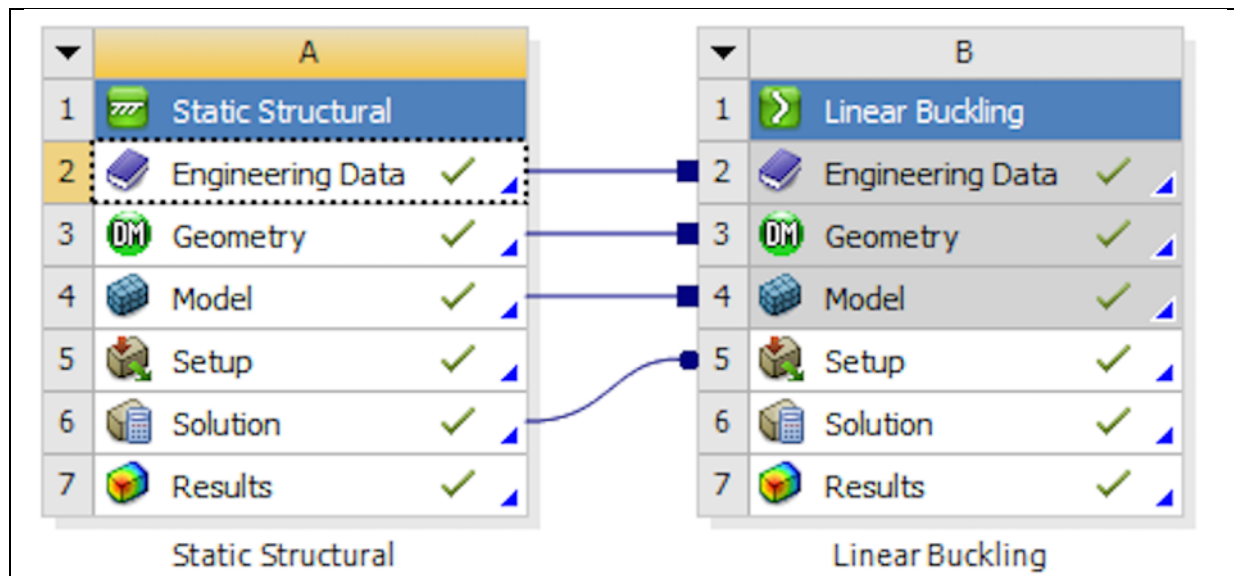
Figure 4 shows the top level ANSYS schematic program to perform static structural analysis followed by linear buckling. In order to build a simulation model, one must work the way down from the top by first specifying engineering data. These are the mechanical properties for each material as defined in Section 3, which are added to the standard ANSYS database of material properties. The solution to static structural analysis is then used as input to linear buckling analysis as shown in Figure 4.

Figure 4: ANSYS schematic program.

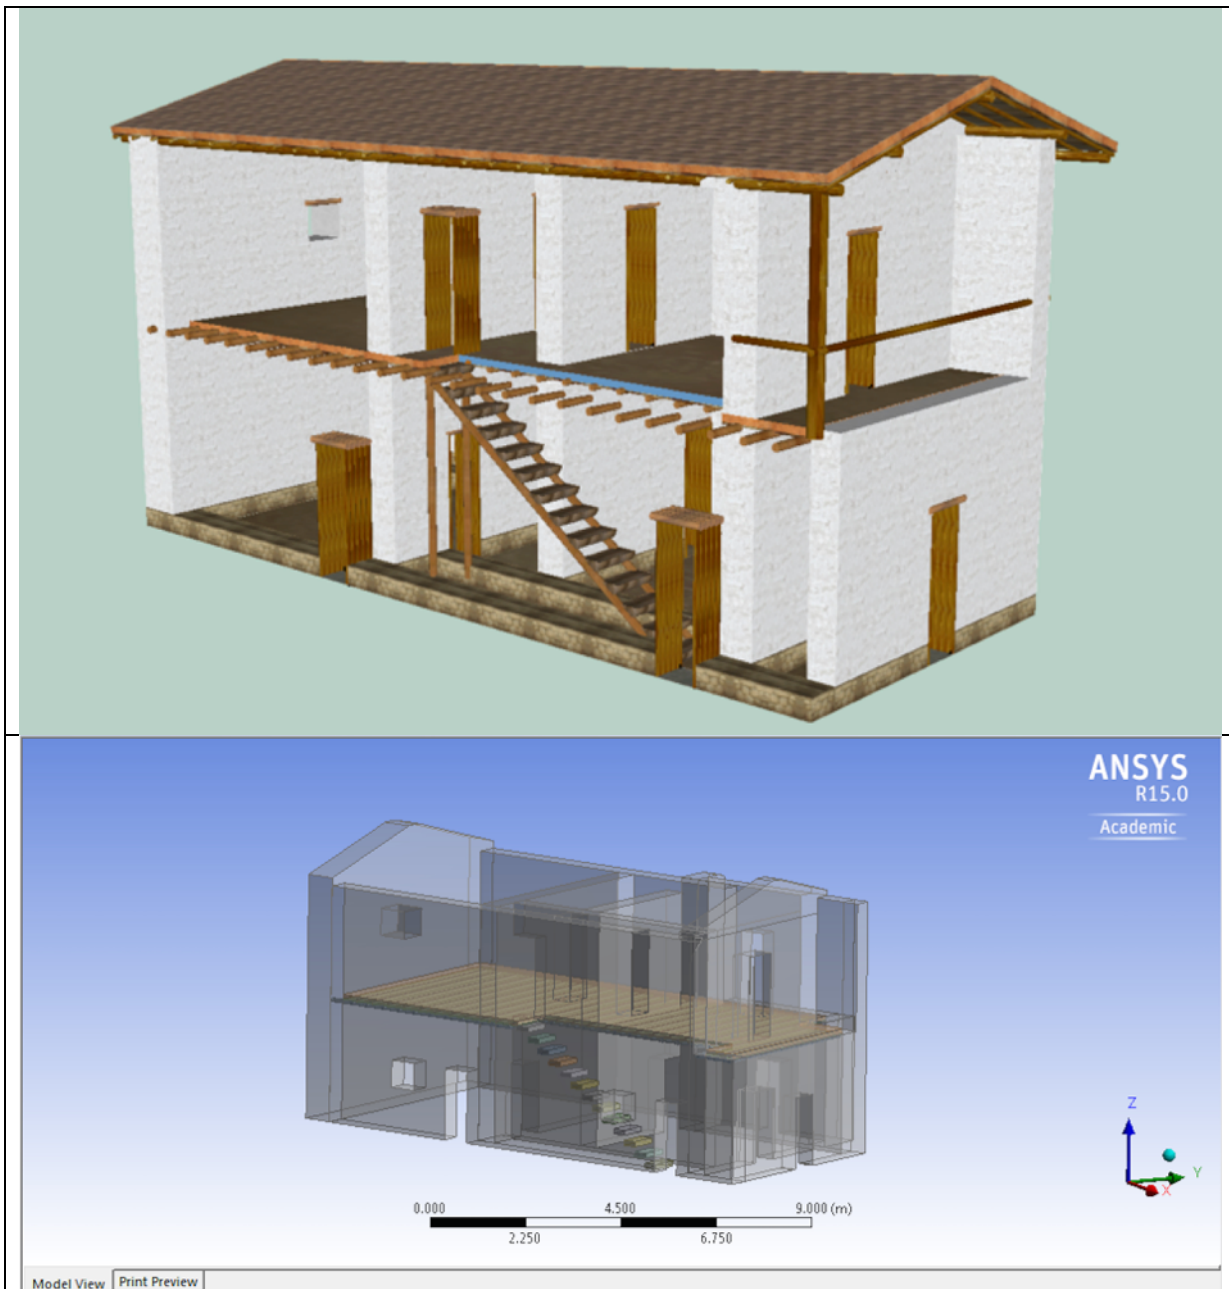
Figure 5: Top: visualization of the 3D model (with some walls removed to show interior); bottom: ANSYS model with roof removed.

Figure 5 top shows the SketchUp model with two walls removed so that the interior floor and stairs could be visualized. Figure 5 bottom shows the imported geometric structures into ANSYS. It is necessary to specify the bonding of various structures before the physically based simulation, that is, whether the various walls are allowed relative motion or not. In the simulations of the HCH we specified that all structures are bonded together and no relative independent motion is allowed.

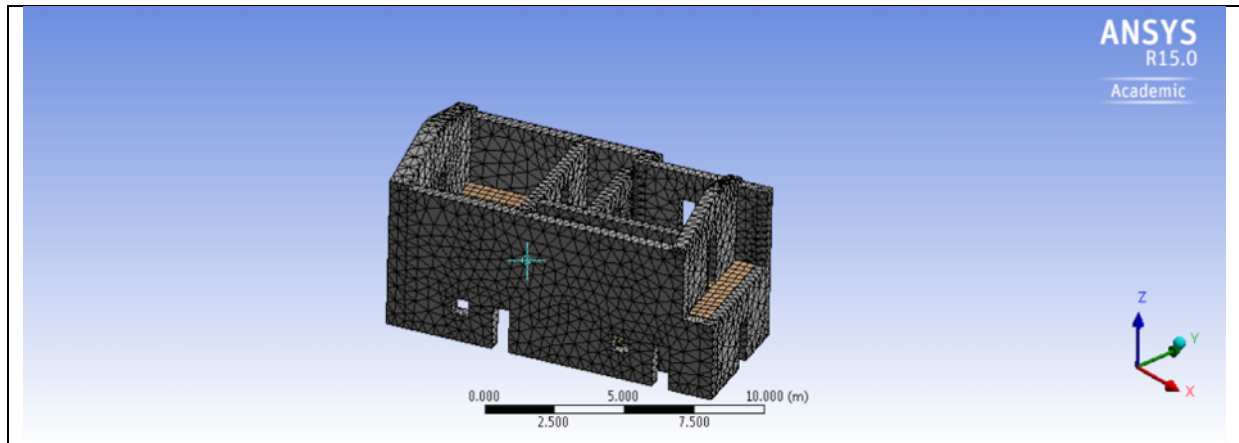
Figure 6: Tetrahedral meshing operation on the 3D structure.

Having imported the geometry, the mechanical *Model* is specified starting from meshing the 3D structure and assigning materials to their respective geometries. ANSYS has a range of meshing tools and mesh refinements to ensure simulations will accurately validate the physical model. We used tetrahedral meshing as depicted in Figure 6. ANSYS has a ‘physics preference setting’ to ensure the most appropriate mesh is generated for each simulation. The size of each element of the mesh can be controlled by the user: the smaller the (finite) element, the more precise the answer, but the price to pay is that of higher computational costs.

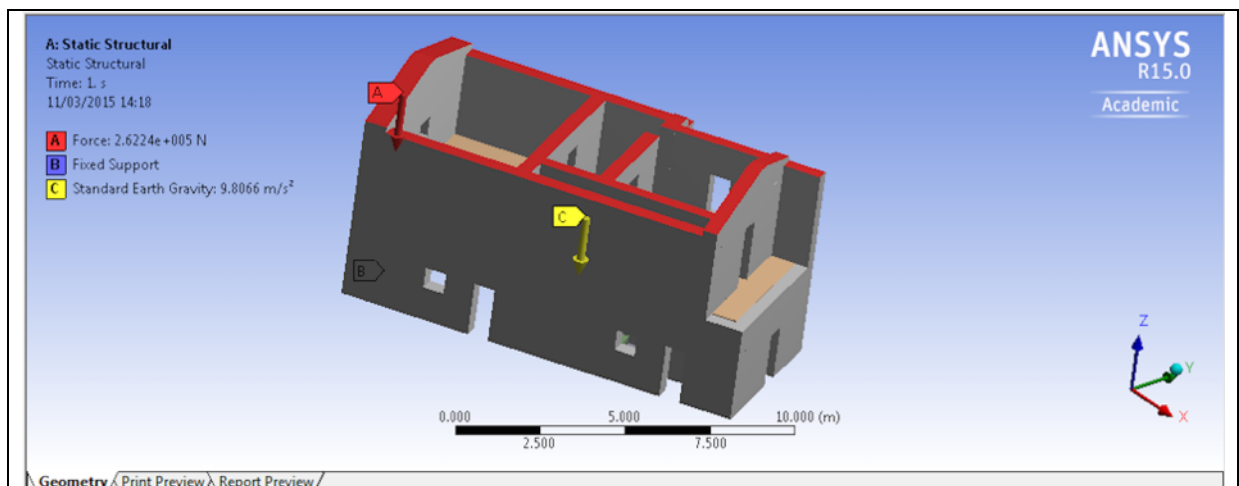
In the *Setup* step the parameters of the analysis, namely all loads, forces and support acting on the structure are specified. Only a single compression force is required given as the total weight of the roof plus the live load. The weight of the roof is carefully calculated from the geometry of its various components using their respective densities. A live load is added equivalent to 1ton (~9,800N) to represent people and furniture, yielding a total downward force of 262,244N acting on the surfaces indicated in red in Figure 7. Inertial forces were also included using the standard gravity acceleration (in yellow), so the weight of the wall acting on every element is also taken into consideration. When considering compression forces due to weight integration effects, note that the bricks at the bottom of the wall near to the ground are placed under considerably higher compression than the ones touching the roof.

Figure 7: Load setup showing downward forces acting on the surfaces in red.

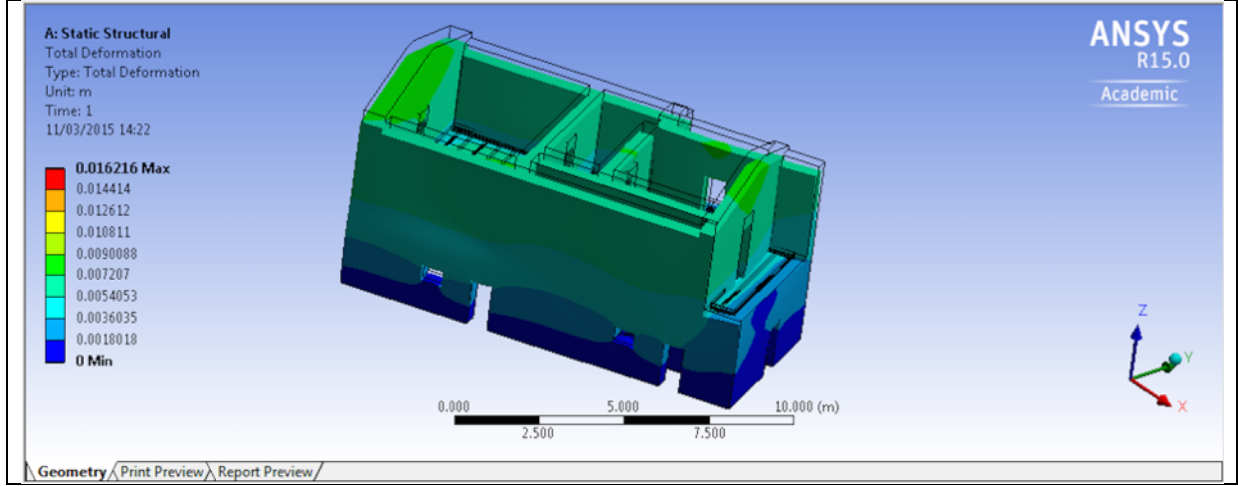
then integrating the results, which can be reviewed using a range of graphical tools and tabular formats. The results for total deformation from static structural analysis are depicted in Figure 8. The maximum deformation for the applied load is 16mm. This would be difficult to show on a 6m tall wall, so the deformation relative to the original outline in Figure 8 is exaggerated for the purposes of visualization.

Figure 8: Total deformation in static structural analysis (exaggerated for visualization).

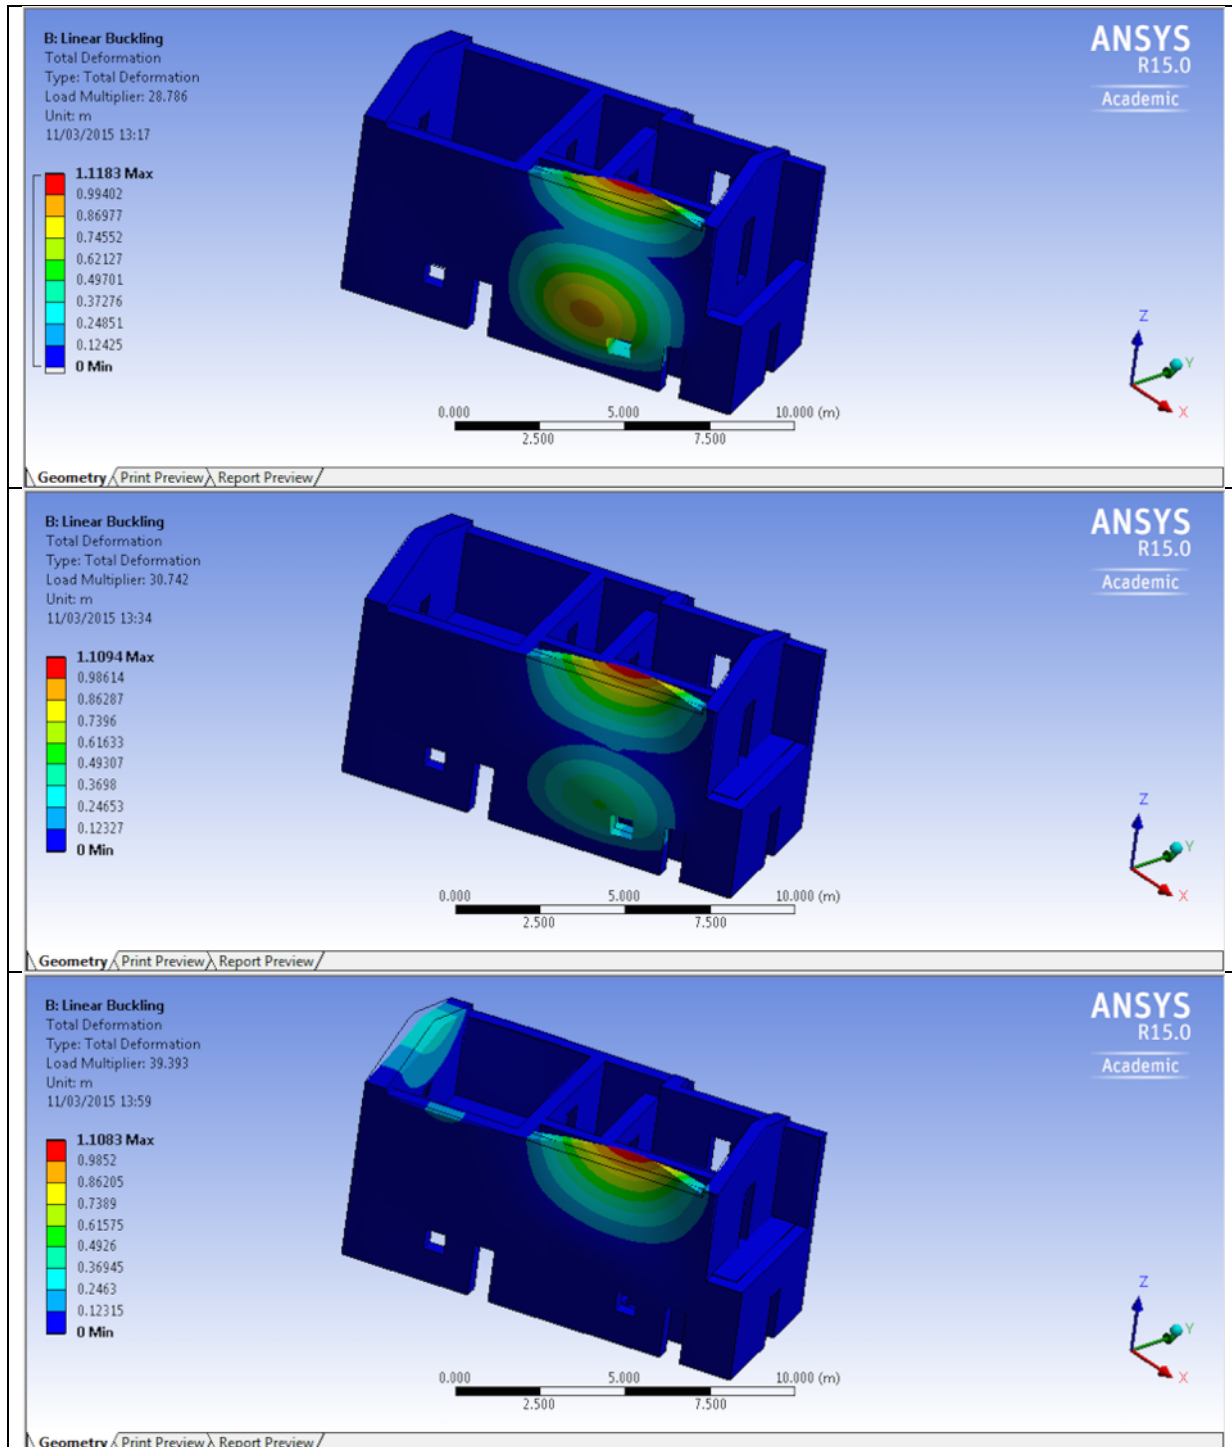
Figure 9: Top: buckling of the HCH structure defined by the walls only; middle: buckling with addition of the upstairs floor; bottom: buckling with the addition of upstairs floor and stairs.

Figure 9 depicts the results of linear buckling analysis for the three cases considered. It can be seen that the weakest area of the house is the external wall of the corridor containing the staircase. The respective buckling load multipliers are 28, 30 and 39 where normally the higher the multiplier the more rigid and stable the structure. The simulations clearly demonstrate the relative importance of the stairs as a structural element as is evident in the highlighted areas of the model and by the change in load multiplier: by adding the upstairs floor, the multiplier goes from 28 to 30 but when stairs are added it goes from 30 to 39. Although these are rough predictions, it is clear that the structure would not collapse under the applied loads in normal circumstances – i.e., in the absence of large external disturbances such as an earthquake.

- The design inferred from the foundation walls is capable of supporting a second floor.
- The wall most susceptible to buckling is the outside wall to the stairs, along the NNE side of the house.

- The addition of the upper floor structure provides the HCH with the advantageous side effect of making the external NNE wall more rigid, and thus reducing the magnitude of buckling.

- The addition of the stairway makes the external NNE wall even more rigid and totally removes the probability of buckling on the ground floor.
- The designers have solved structural buckling issues by adding internal transverse walls at 90 degrees to the double NNE wall and to the west façade corridors, which made the structure more rigid and less susceptible to buckling. Instead of providing access to the second floor, these corridors may have accommodated supplementary rooms in the periphery of the ground floor and a more complex entrance, and had possibly supported one or more upper floor balconies.
