Residual Stresses in Condition Monitoring and Repair of Thermal Power Generation Components

M.N. James, D.G. Hattingh, D. Asquith, M. Newby, P. Doubell

To appear in: *Theoretical and Applied Fracture Mechanics*

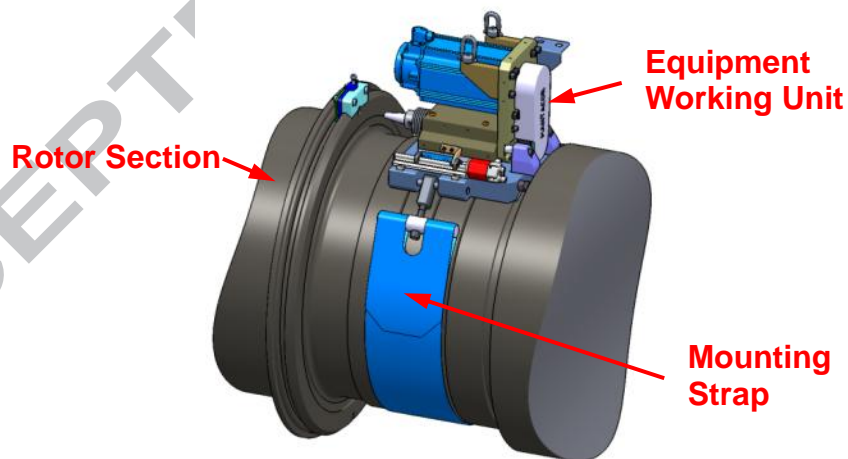
Figure 2 Illustration of the bespoke FTTP platform in position on a stream turbine rotor. It uses the registered WeldCore® process and is capable of extracting an annular metallurgical sample through the thickness of the blade attachment T-slot wall, repairing and re-drilling the hole in a single sequence of operations.

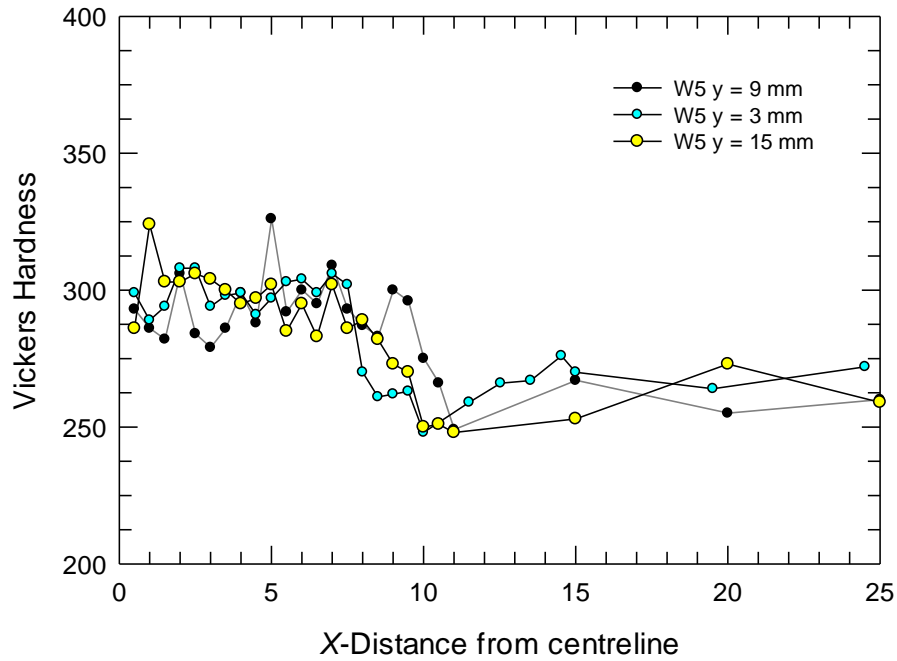
Figure 4 Vickers hardness profiles under a 500gf load in specimen W5 (un-drilled and PWHT) at three depths in the 18 mm thick steel.

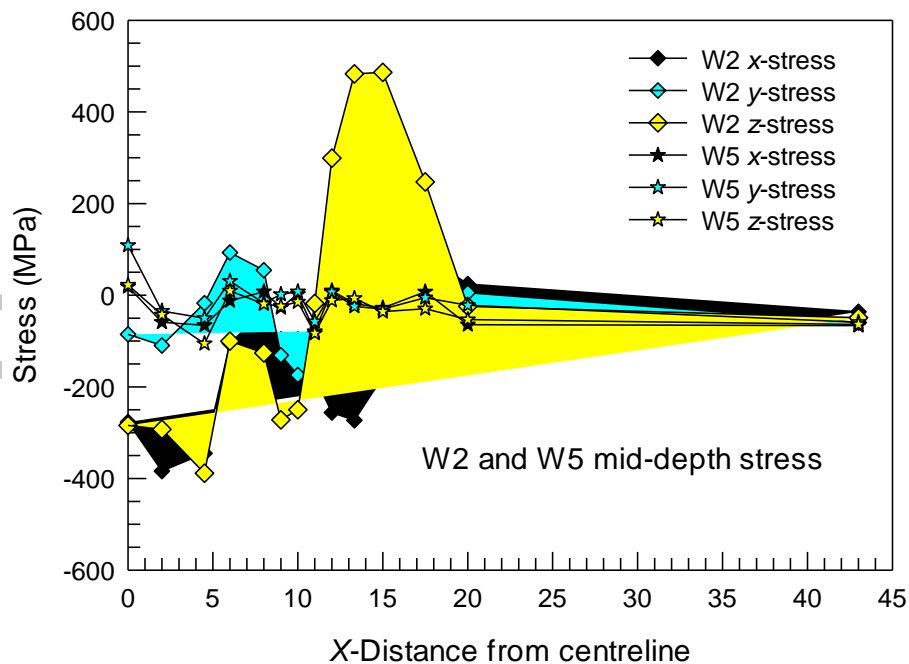
Figure 5 Comparison between the mid-depth values of residual stress in all three coordinate directions for specimens W2 (as-welded and undrilled) and W5. The edge of the original hole in the blade would have been at the $x = 4$ mm position.

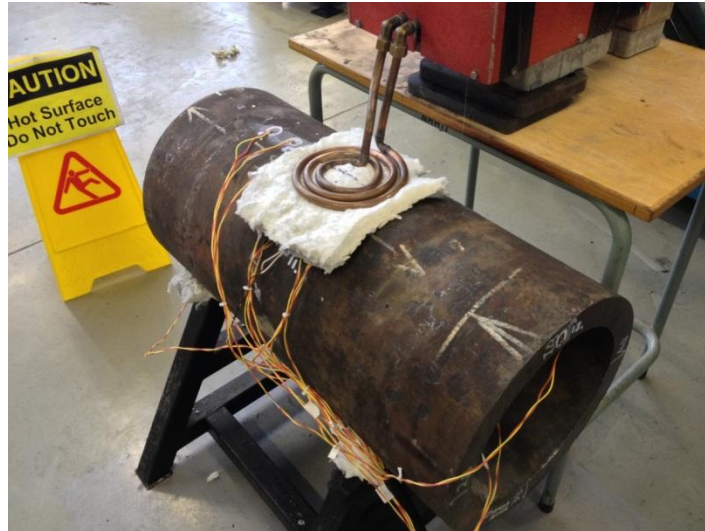
Figure 7 Induction heat treatment of the pipe after completion of the WeldCore® process.

number 1.7380). The PWHT was limited to a maximum surface temperature of 800°C and induction heating was continued until the inner surface of the pipe reached 650°C which was then maintained for a minimum of 15 minutes. Cooling took place in still air conditions in the laboratory.

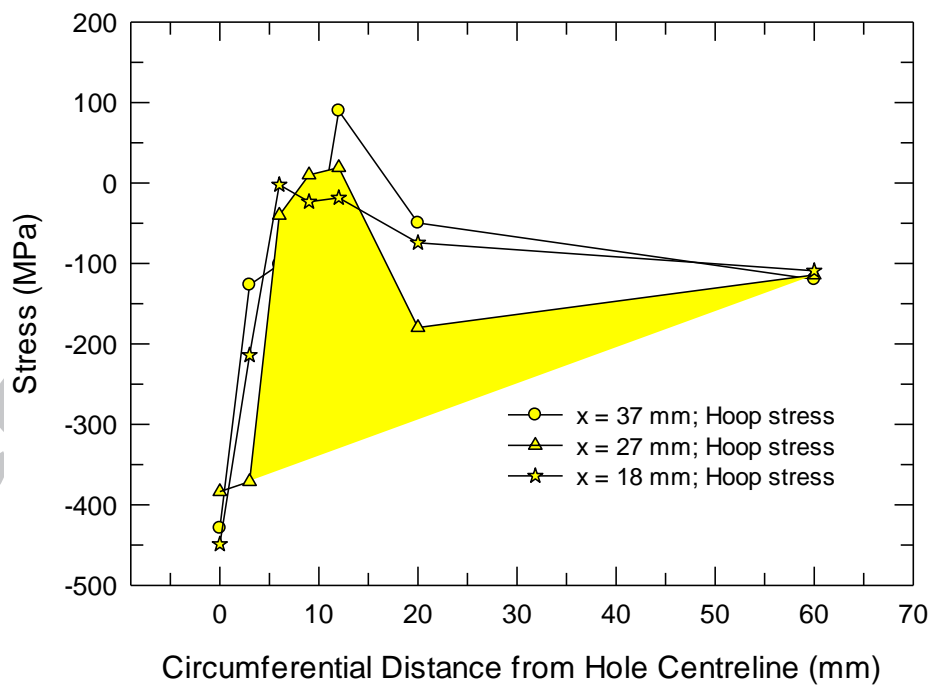
Figure 8a Residual hoop stresses in the as-welded FTHP specimen 1A.

Measurements were made of the residual stresses in the hoop, radial and axial directions of the pipe at three positions through the wall thickness (18 mm, 27 mm and 37 mm from the outer surface) at a number of positions from the weld centreline to a distance of 60 mm. Figure 8 shows the measured residual hoop stresses in specimen 1A (as-welded – Figure 8a) and specimen 2B (PWHT – Figure 8b) while Figure 9 shows the corresponding data in the axial direction. In terms of crack initiation during service, these are the two key coordinate directions. Measurements were able to be made at 5 depths in the PWHT specimen, while data was obtained at only three depths in the as-welded specimen.

Certain observations can be made from these hoop stress data; firstly, that at depths of 18 mm, 27 mm and 37 mm below the surface of the pipe, the large negative peaks that occur around the edge of the weld metal are reduced from peak values in the range 380 MPa to 450 MPa in the as-welded state, to values after PWHT in a range around 275 MPa to 380 MPa. Secondly, the values of peak tensile hoop stress are also reduced at equivalent depths and, thirdly, the stress distribution moves in the tensile direction the closer to the outer surface the measurements are made (e.g. Figure 9b, $x = 9$ mm and $x = 4$ mm). In all cases where data was obtained, the level of peak tensile residual hoop stress is < 120 MPa.

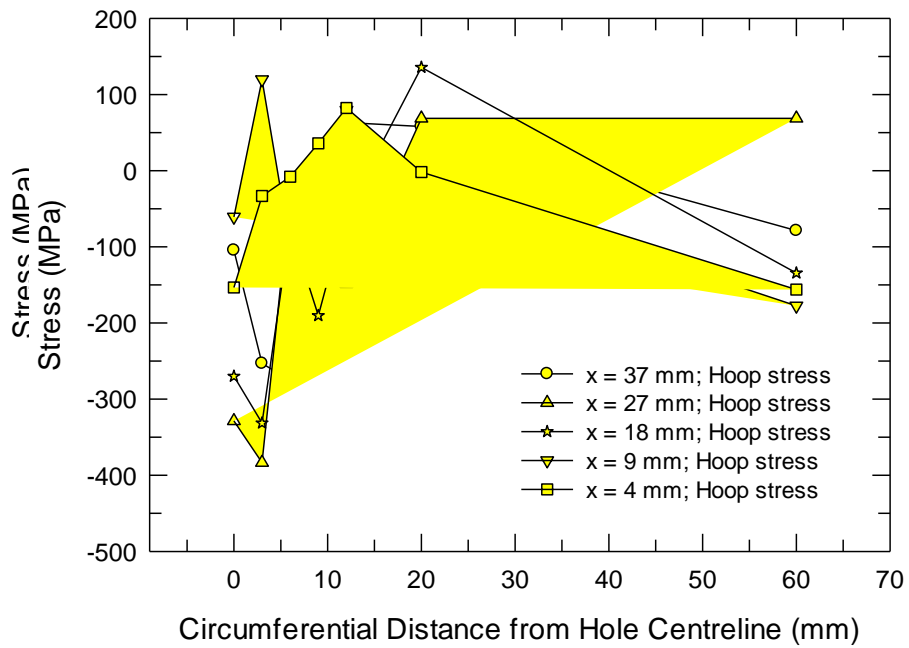
Figure 8b Residual hoop stresses in specimen 2B after local PWHT by inductive coil.

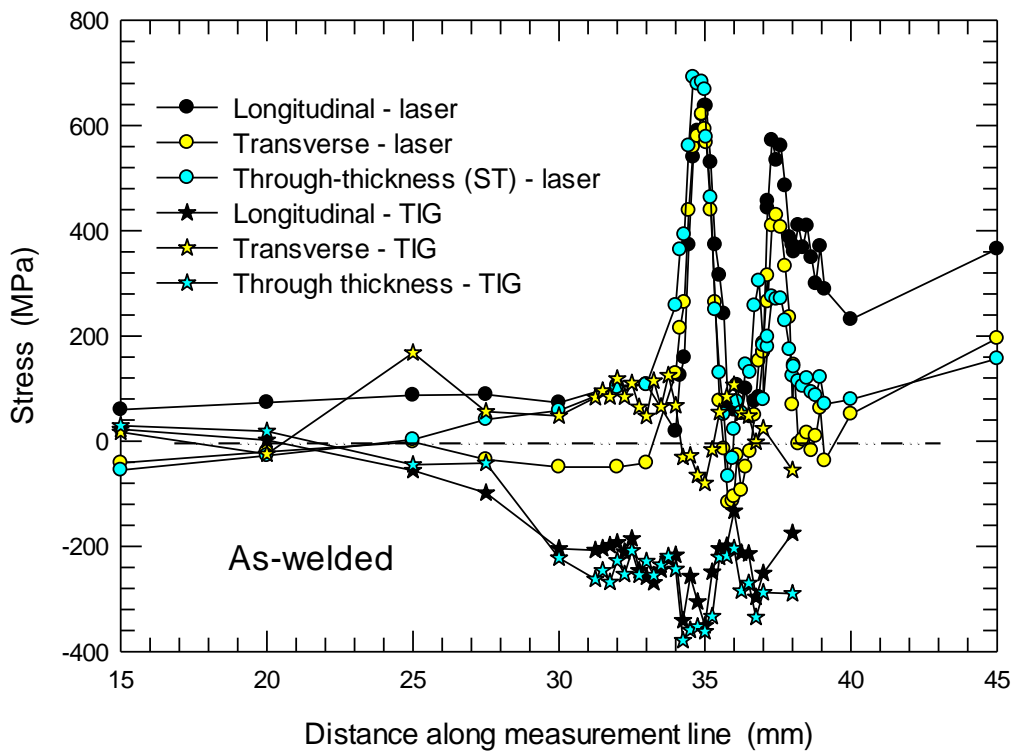
Figure 12a Residual stress data measured in the as-welded laser (specimen 2) and TIG welded (specimen 5) tenon samples.

The resulting 3D residual stress data are shown and compared for the two cases in Figure 12a (as-welded) and Figure 12b (PWHT). The zero point for the x-axis of Figure 12 is the bottom surface of the test coupon, so the original fusion boundary is at $x = 35$ mm.

For the laser welded specimen in the as-welded condition, it is clear that a substantial level of triaxial tensile stress exists on either side of the fusion boundary with peak values of circa 600 MPa. Across the fusion boundary the peak stresses reduce in magnitude with the values in the T and ST directions tending to be negative, while the longitudinal stress remains tensile. The turbine blade tenons in an as-welded state would hence be exposed to a significant risk of experiencing SCC, hydrogen-assisted cracking or fatigue. In contrast after PWHT, the residual stress peaks are more localised around the fusion boundary transition and the peak tensile values are reduced to between 100 – 120 MPa. A small region (≈ 2 mm wide) of triaxial tension still remains associated with the fusion boundary zone. PWHT has therefore been quite successful in the laser welded case in reducing residual stress magnitudes and hence in reducing the possibility of crack initiation and growth during service.

The TIG welded specimens show rather different behaviour with tensile stresses occurring near the fusion boundary for the as-welded case only in the transverse direction and having peak values < 200 MPa. Measured residual stress values are negative in the L and ST directions with peak values much greater (circa -400 MPa) than those observed with the laser welding (circa -100 MPa). For the PWHT TIG welded specimen the overall pattern of the residual stress field is similar to that observed for the laser welded case although peak negative values of stress are significantly higher in the TIG welded case at around -400 MPa than the values in the laser welded case (-300 MPa). The PWHT appears to primarily have affected residual stresses in the transverse direction and has made them more negative.
