An Experimental Method for Fatigue Testing Cast Iron Water Pipes Using Combined Internal Water Pressure and Bending Loads

E. D. A. John¹ · J. B. Boxall¹ · R. P. Collins¹ · E. T. Bowman¹ · L. Susmel²

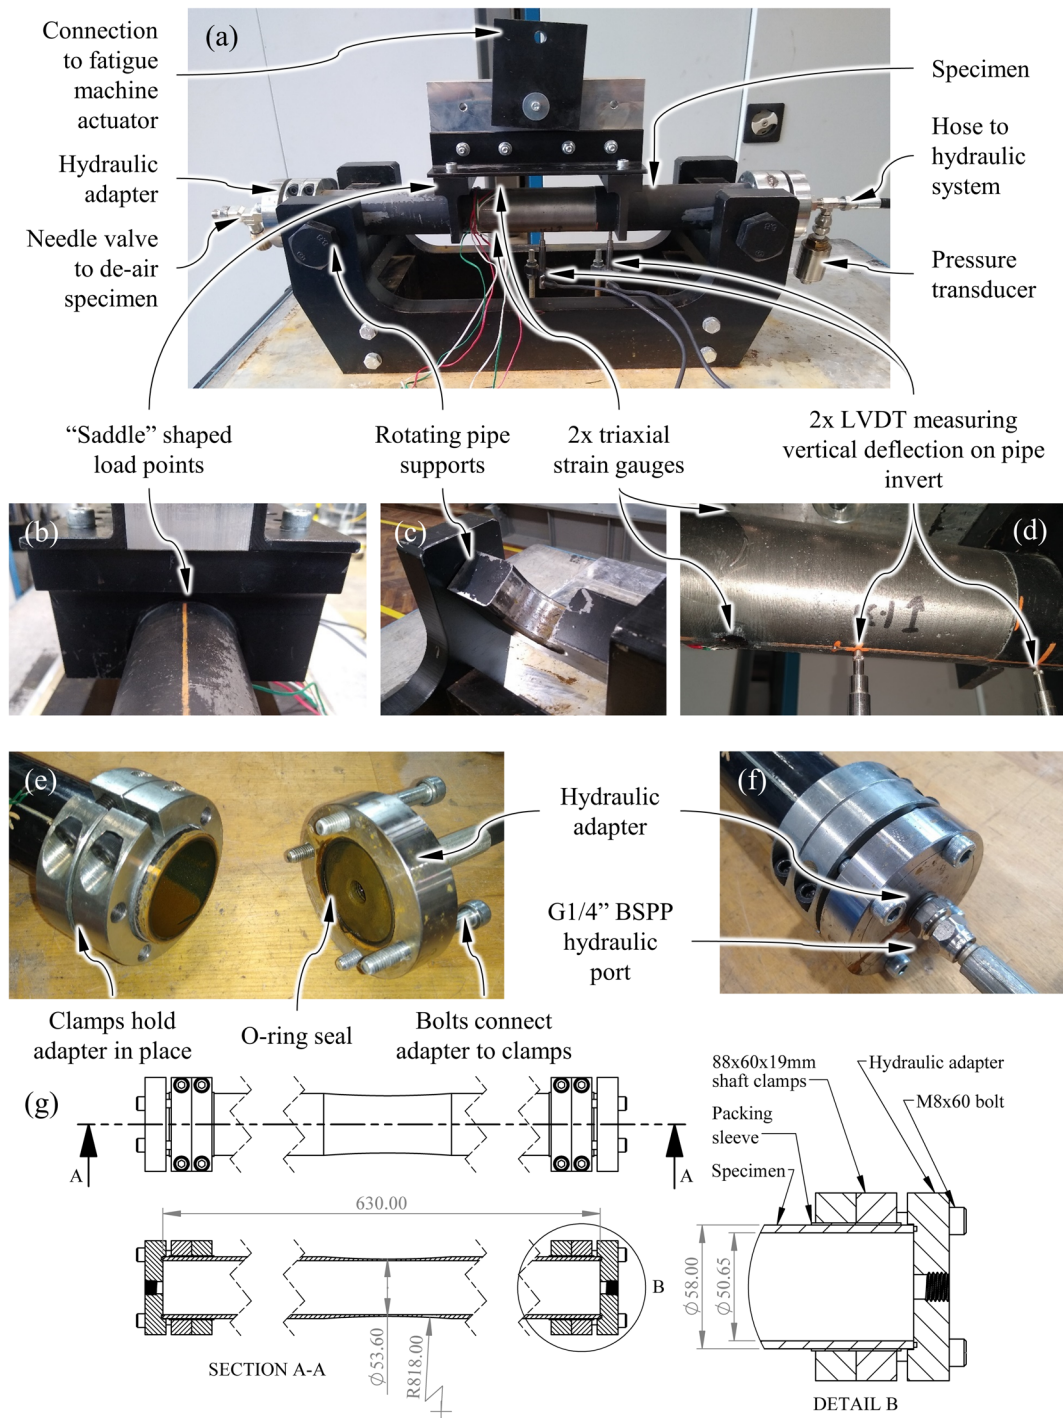
Fig. 1 Labelled photographs and drawings showing the four-point bending apparatus, pipe specimens, and pipe specimen hydraulic adapters

To create a region of constant maximum bending stress in the pipe specimens away from the stress-concentrating influence of the load points a four-point bending arrangement was used. The design of the supports and load points was developed to cause conditions close to an ideal, simply supported, four-point bending case.

constant stress away from the load points a reduced gauge diameter was machined from the centre of the specimens, shown by Fig. 1(g). The fatigue mechanisms governing failure remain the same for failures within the high-cycle fatigue regime, so the trial destructive tests targeted failures between 10^3 and 10^4 load cycles. During each test an internal pressure amplitude around 3.8 MPa, with a load ratio of 0.12, and a bending load amplitude around 4.4 kN, with a load ratio of 0.1, were applied 180° out-of-phase to the pipe specimens. The exact loads were adjusted to account for slight variations in specimen geometry. Tests were suspended if failure did not occur after 10^5 load cycles.

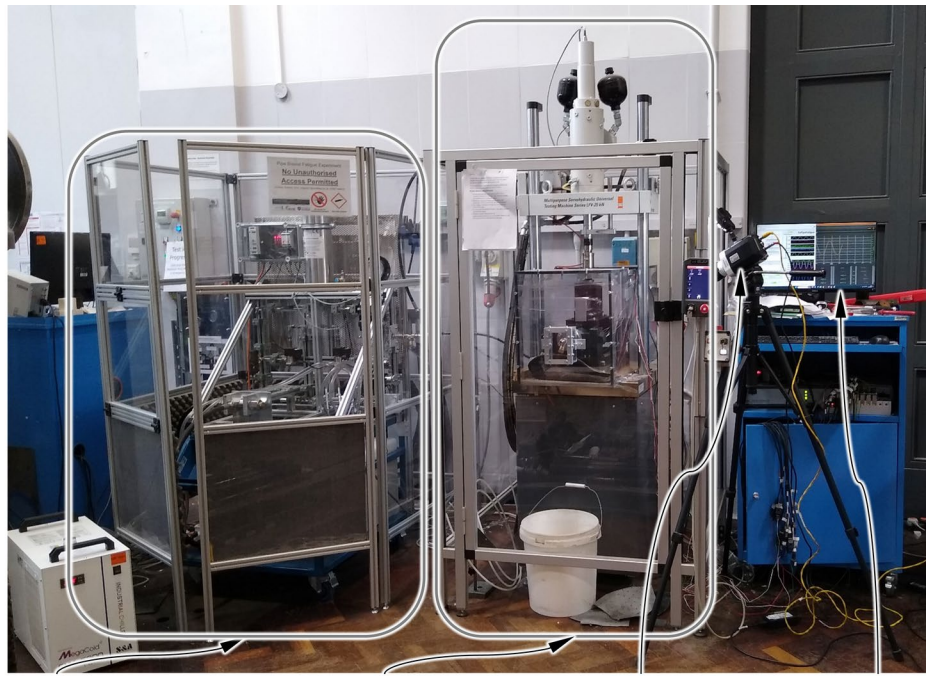
Internal water pressure
loading hydraulic system

LFV-25-ME fatigue machine
with bending apparatus

PC running LabView and
LFV-25-ME software

Fig. 2 Labelled photograph showing the full experimental set-up

So that the stability of leaking fatigue cracks could be observed the system was designed to continue applying internal pressure loading after a small leak had formed. A pump was used to maintain pressure in the high-pressure reservoir before and after a leak formed (Fig. 3, PD1). This pump was supplied as part of a Hydrostatic Test Unit (HTU) as shown by Fig. 3. The high-pressure reservoir was a nitrogen-charged accumulator with a working volume of 2 L (Fig. 3, A2). The bespoke fatigue valve system (see Fig. 3) was mounted on the wheeled HTU frame and positioned within a safety enclosure next to the servo-hydraulic fatigue testing system (see Fig. 2).

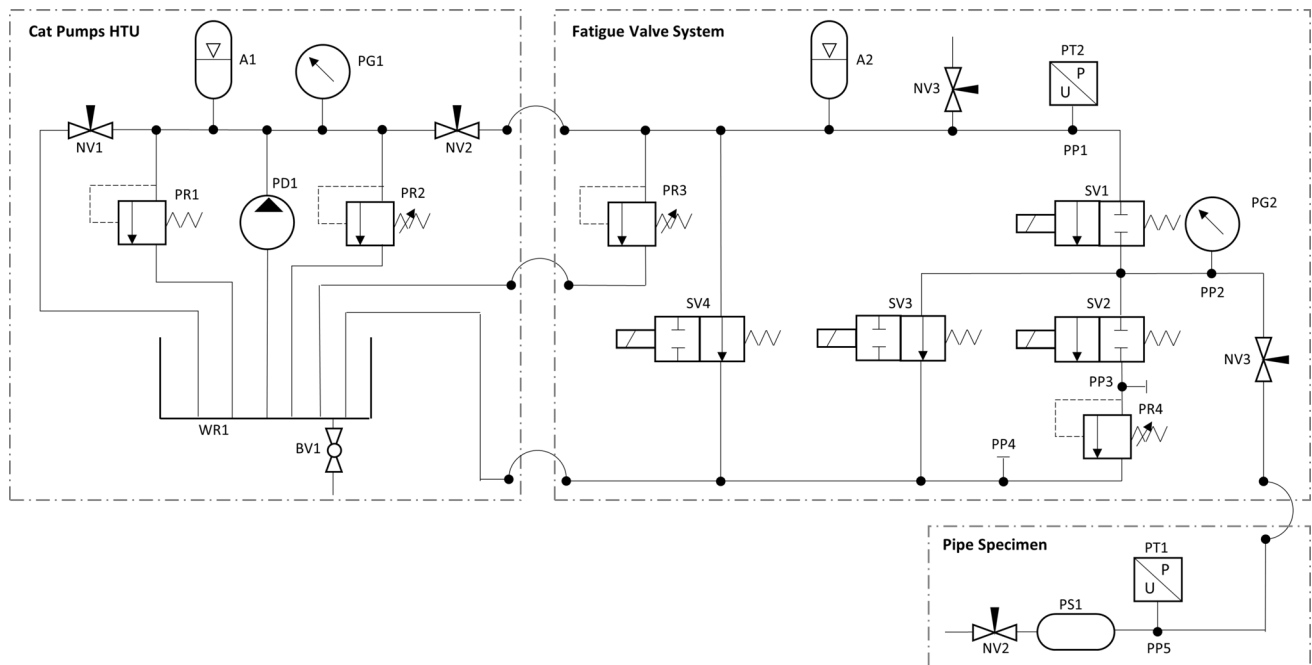
Fig. 3 Full schematic for the hydraulic system used to apply internal water pressure fatigue loading to pipe specimens (see Table 1 for component details)

To enable fatigue tests of up to 10^5 cycles to be completed within a few days (during working hours), the system was designed for a loading frequency of 2 Hz. So that this fast cycle frequency could be achieved, a pair of solenoid valves (Fig. 3, SV1 and SV2) were used to alternately

expose the pipe specimen to a high-pressure reservoir (Fig. 3, A2) and low-pressure reservoir (Fig. 3, WR1) thereby cycling the pressure in the specimen between two controlled pressure levels. Using solenoid valves also enabled precise control of the pressure cycle timings. To reduce the risk of cavitation, the minimum cycle pressure was held above zero using a manually set pressure control

valve on the hydraulic line to the low-pressure reservoir (Fig. 3, PR4). The maximum cyclic pressure could be set between 3.5 and 20.0 MPa (using PR2 and PR3, Fig. 3),

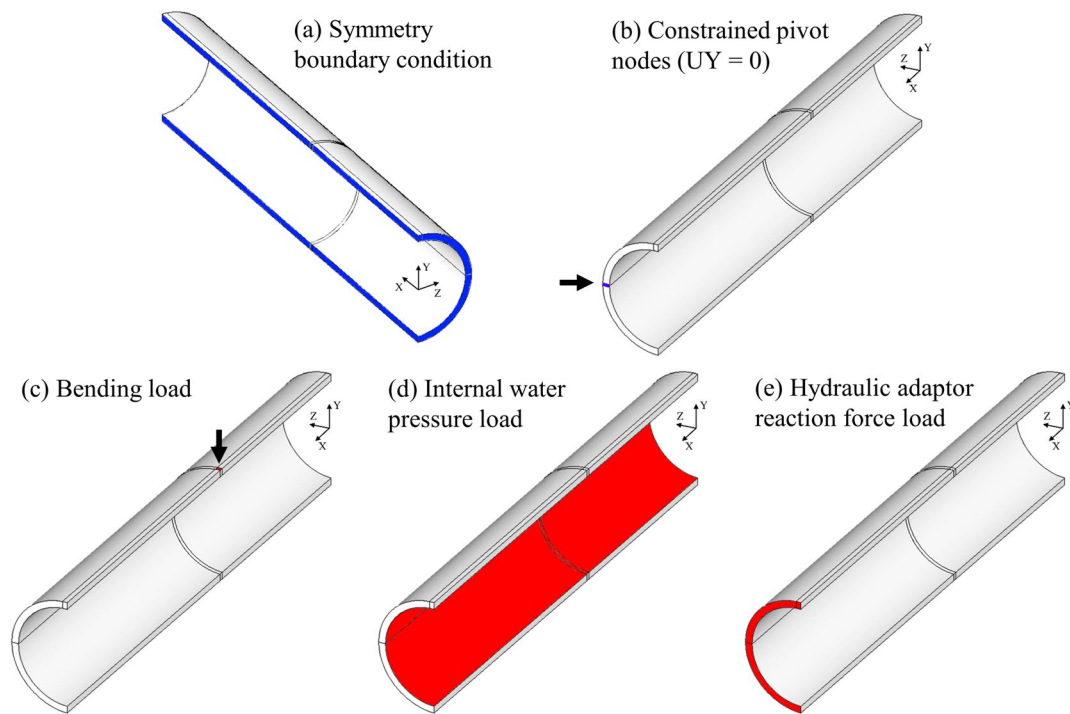
Fig. 4 Diagrams showing the boundary conditions (shaded blue) and loads (shaded red) applied to the four-point bending and internal water pressure load finite element model

To calculate strain and displacement using FEA, a quarter-pipe model was developed which exploited the two planes of symmetry present in the experiment, as shown by Fig. 4(a). The simply-supported aspect of four-point bending was modelled by constraining the vertical movement ($U_y = 0$) of a horizontal row of nodes at the pipe neutral axis (Fig. 4(b)). To approximate the point loads of four-point bending, the bending load was applied as a uniformly distributed pressure force over a small 2×2 mm patch (Fig. 4(c)). The internal water pressure load was applied to the inside faces of the specimen model as a uniformly distributed pressure (Fig. 4(d)). To account for the fact that the specimens were subject to an axial load caused by the internal water pressure reaction force on the hydraulic adaptors at each end of the specimen, a uniform pressure load with a negative magnitude was applied to the end face of the specimen model (Fig. 4(e)). A second-order hexahedral element mapped mesh with a 1 mm element size was used to discretise the specimen model. Mesh refinement confirmed that a 1 mm mesh size was sufficiently free from discretisation errors.

The four-point bending equipment developed was able to load pipe specimens in a way that was very close to ideal four-point bending according to the classical beam theory solution, although, deformation of the pipe cross-section meant that the experimental strains were closer to the FEA estimations than the analytical estimations. Deformation of the pipe cross-section is evidenced by disagreement between the analytical solution and the strains measured around the pipe circumference, shown by Fig. 5(b). The finite element model boundary conditions, which can be assumed to reflect the experiment boundary conditions, included a pinned joint at the specimens' geometric centroid that was free to rotate and translate, except in the vertical direction (see Fig. 4(b)), which is very similar to the simply supported condition.

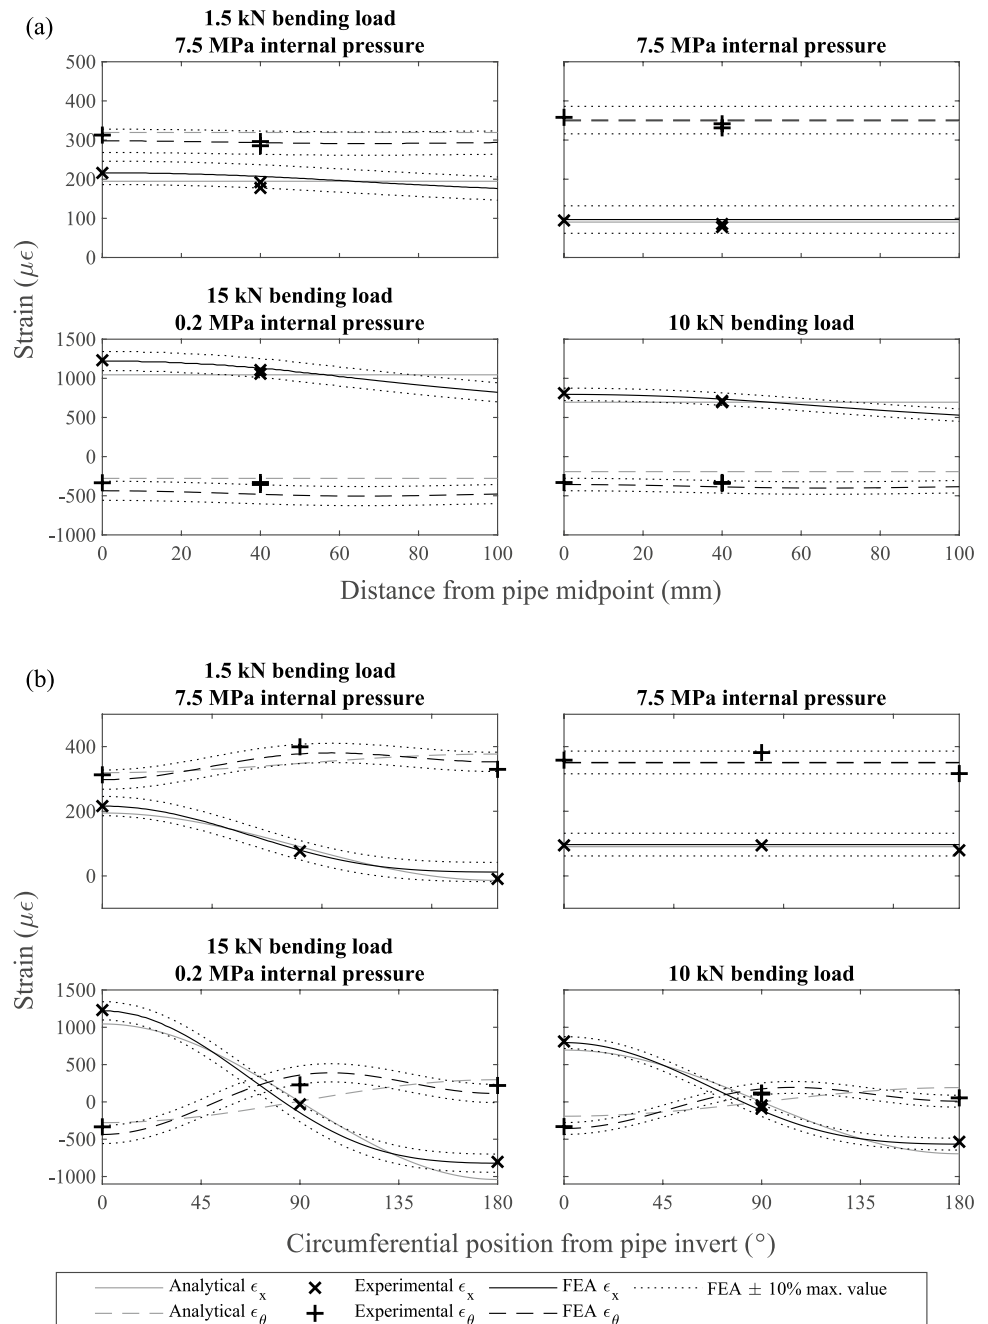
Fig. 5 Measured and predicted strains (a) along the invert and (b) around the midpoint circumference of one of the specimens used for the strain and displacement validation experiments

presented here in graphical form. For that specimen, for each loading condition the measured and estimated strains along the specimen invert are shown in Fig. 5(a), and the measured and estimated strains around the circumference in the middle of the specimen are shown in Fig. 5(b). The measured and predicted vertical displacements along the specimen invert for the same specimen are shown in Fig. 6. Note that the vertical displacement measurements and predictions for the 7.5 MPa internal water pressure loading case are not provided as these were too small to measure reliably. To avoid penalising low magnitude strain readings the FEA

All but three invert strain measurements across both specimens fell within $\pm 10\%$ of the maximum predicted strain of the FEA predictions. The greatest invert strain error was 12.4% for a strain measurement of $-330 \mu\epsilon$ and all invert strain measurements falling outside the $\pm 10\%$ FEA prediction bands were located 40 mm away from the midpoint. All but one circumference strain measurement fell within $\pm 10\%$ of the maximum predicted strain of the FEA predictions.

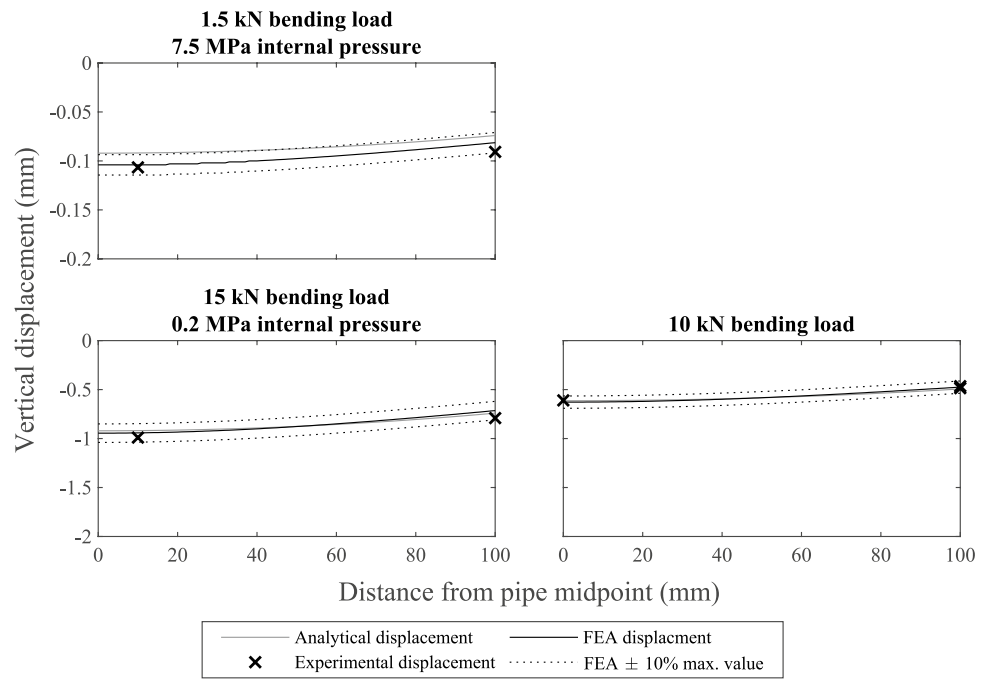
Fig. 6 Measured and predicted vertical displacements along the invert of one of the specimens used for the strain and displacement validation experiments

The greatest circumference strain error was 10.8% for a strain measurement of $228 \mu\epsilon$. Only two invert displacement measurements fell outside the $\pm 10\%$ FEA prediction bands and these were both for the second pipe under the lowest bending load, meaning the measured displacement was very small (around -0.1 mm). The maximum error was 14.8%.

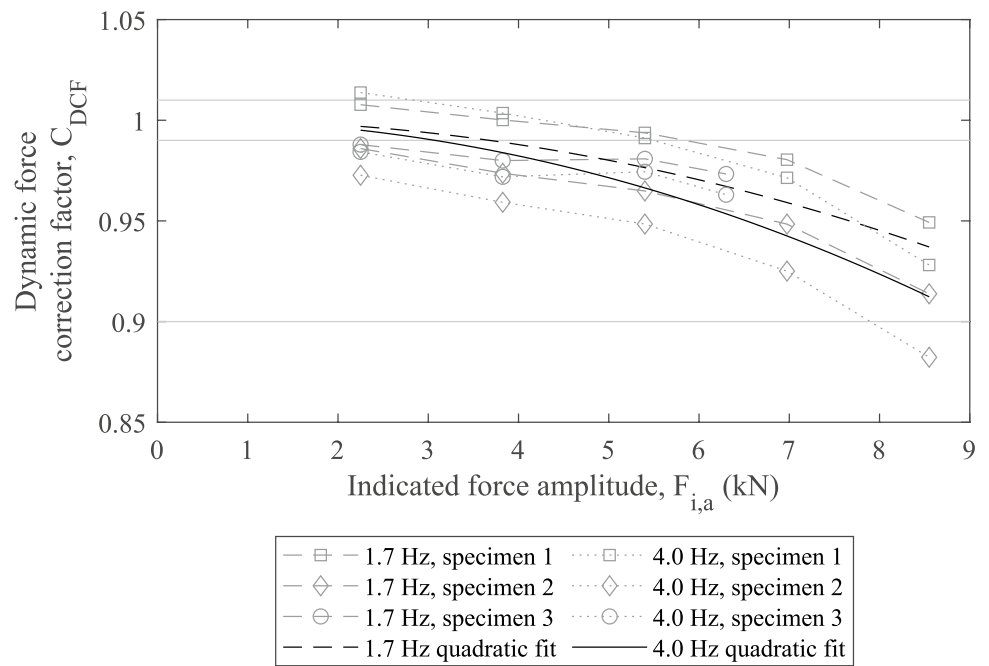
Fig. 7 Plot of measured C_{DCF} values and calculated quadratic fits. Specimen 1 and 2 featured no gauge section reduction while specimen 3 had a reduced gauge section (horizontal grey lines indicate the $\pm 1\%$ and -10% error limits)

These quadratic fits provided good approximations of the non-linear trend observed for each specimen, however, due to the scattering of the observations the R^2 values were low at 0.67 and 0.64, respectively. The quadratic fits fell within the $\pm 10\%$ error threshold and show that on average the dynamic force error was greater at 4.0 Hz than at 1.7 Hz.

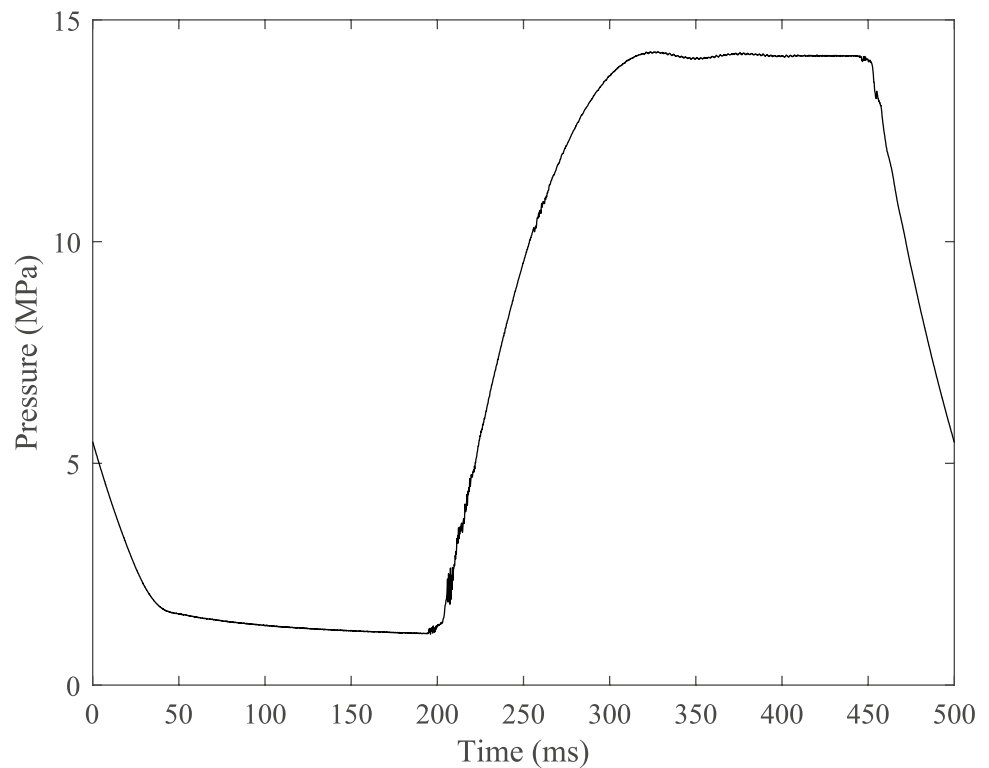
Fig. 8 Plot of a single 2 Hz internal water pressure cycle recorded at a 10 kHz sampling rate

Figure 8 shows a representative 2 Hz loading frequency, 6.55 MPa amplitude internal water pressure cycle measured at a 10 kHz sampling rate. Several very high-frequency pressure instabilities with an amplitude of about 0.41 MPa occurred at the start of the pressure increase (at about 210 ms in Fig. 8), likely caused by the sudden opening of the solenoid valve. A small amount of overshoot occurred as the maximum pressure was reached (at about 300 ms in Fig. 8) resulting in a high-frequency oscillation with a maximum amplitude of 0.08 MPa. The maximum amplitude of a sub-cycle was therefore about 6.3% of the main cycle amplitude.

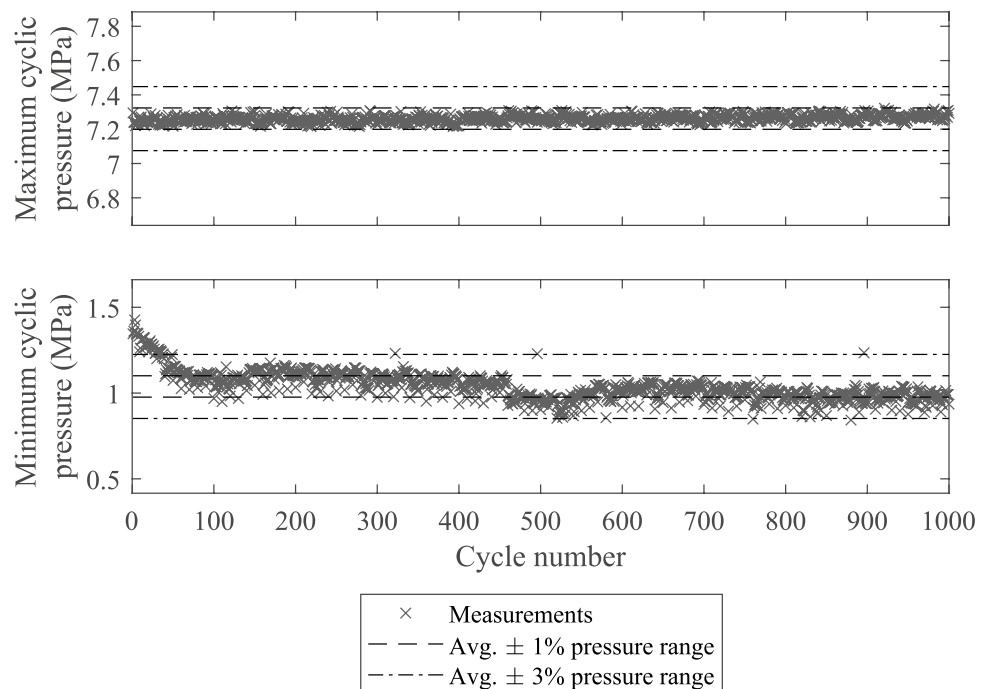
Fig. 9 Plot of measured maximum and minimum cyclic pressures for internal water pressure loading over 10^3 cycles for test 3 from Table 2

amplitudes within $\pm 3\%$ of the average, however, for test 3 95.3% of cycles fell within this range. Figure 9 shows the minimum and maximum cyclic pressures for test 3. The accuracy of the maximum pressure values for test 3 were very good, all falling within $\pm 1\%$ of the average. During the first 100 pressure cycles of test 3 the minimum cyclic

pressures gradually stabilised. The final row of Table 2 gives the amplitude error for test 3 excluding the cycles before the hundredth, from which it can be seen that the percentage of cycles with an amplitude error within $\pm 3\%$ was 99.6%.

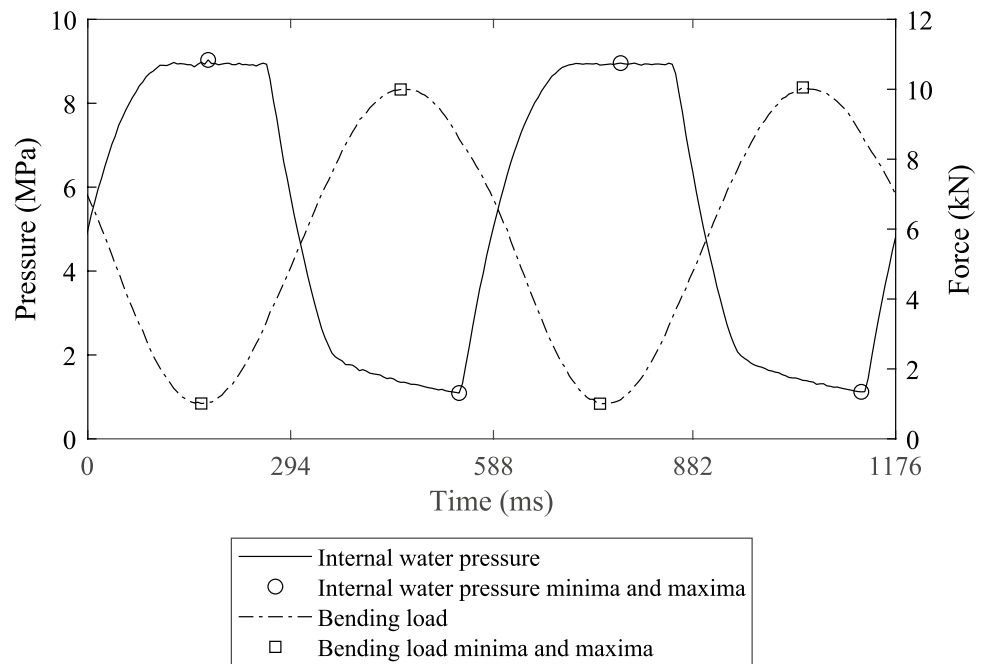
Fig. 10 Plot of measured internal water pressure and bending load for 180° out-of-phase loading during test 2 from Table 3

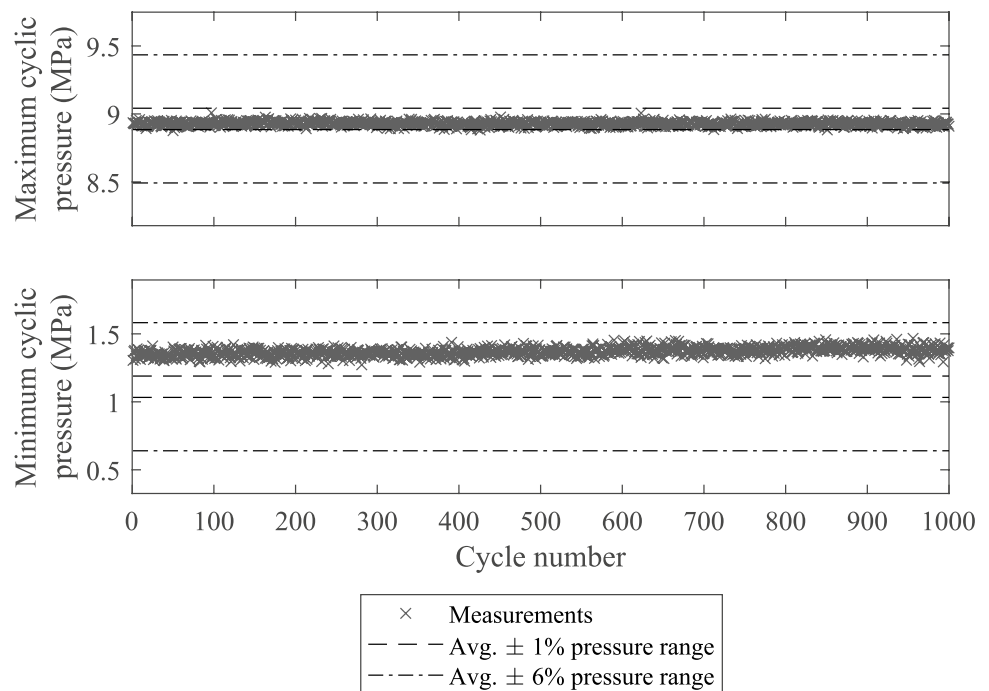
Fig. 11 Plot of measured cyclic pressures during 180° out-of-phase bending and internal pressure loading defined using the location of maximum and minimum bending loads over 10^3 cycles for test 2 from Table 3

Figure 11 shows the minimum and maximum cyclic pressures for test 2, which were representative of the trends observed in the other two tests. It can be seen from Fig. 11 that the chosen load phasing gave maximum cyclic pressures, defined at the minimum cyclic bending load, within $\pm 1\%$ of the true value. The minimum pressure, defined at the maximum cyclic bending load, was consistently above the true minimum cyclic pressure, however, the degree of

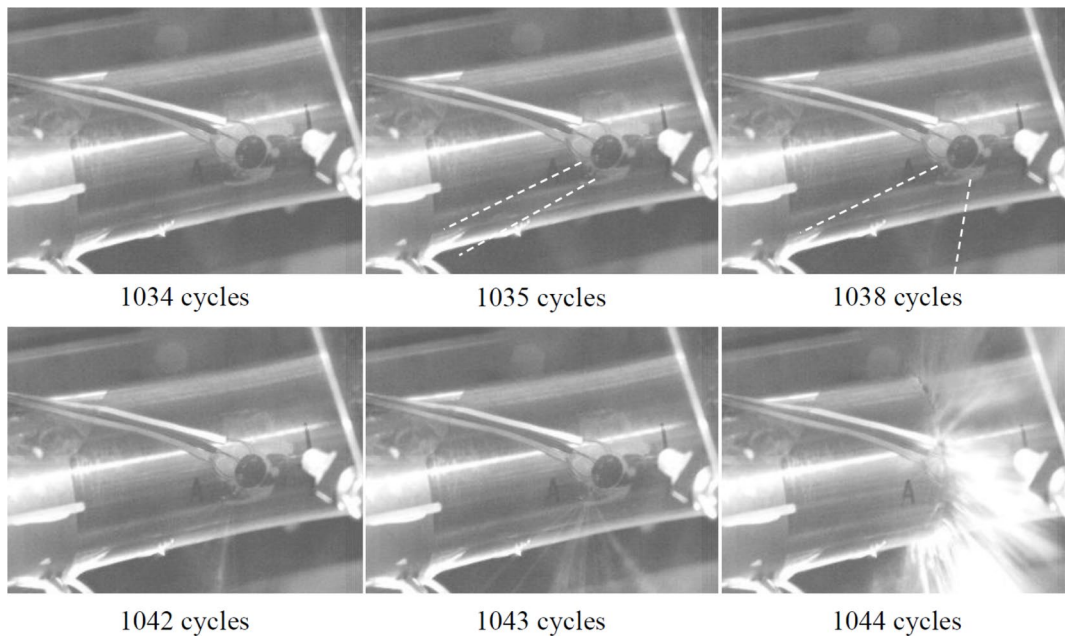
Fig. 12 High-speed video stills showing the evolution of a leak at the invert of a pipe specimen prior to failure under 180° out-of-phase internal water pressure and bending loading (white dashed lines indicate the position of the water jet where this is faint)

Using high-speed camera footage, leaks were detected in the pipe specimens prior to bursting (see Fig. 12). These leaks persisted for less than 1% of the total cycles-to-burst, indicating that in-service GCI pipes in similar conditions are unlikely to experience prolonged periods of leakage and will instead burst with limited warning.
